STAFF REPORT

Subject: Approval of Denniston Filter Repair Change Order

Subject: Denniston Water Treatment Plant Filter Inspection

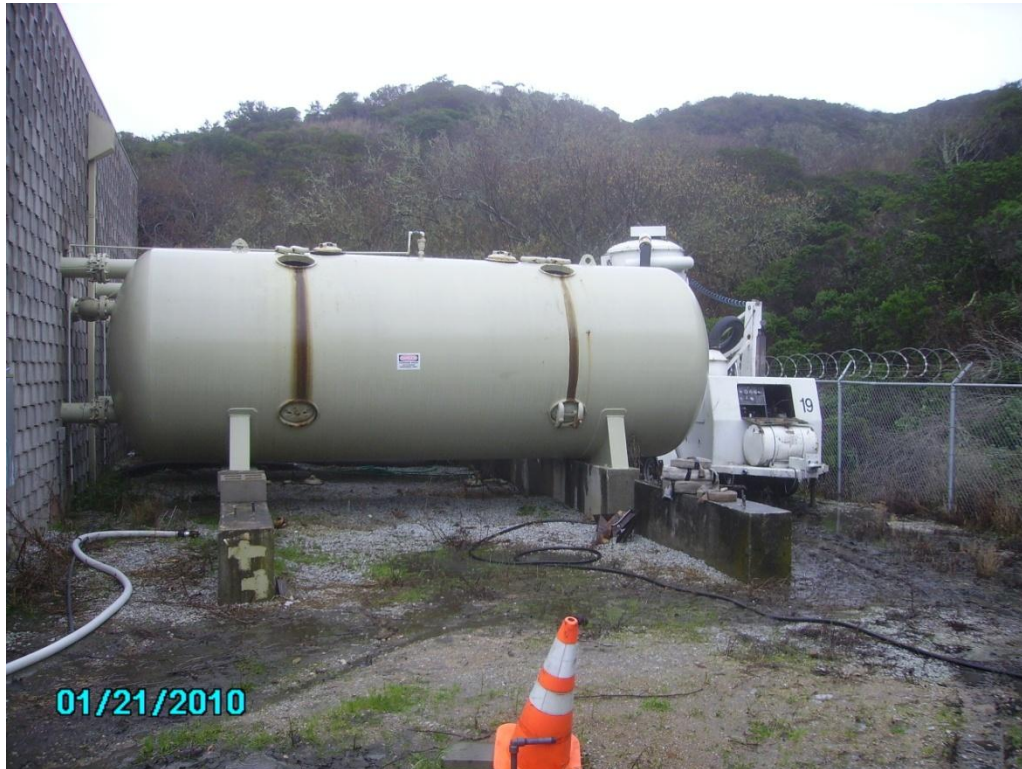
removing media from Filter 1 (See Photo 1). Media removal from Filter 3 had not been started, yet. We also met with Steve Twitchell to gain a more complete understanding of the history of problems and discuss possible causes and solutions. My second visit to the plant was on January 26, 2010, after all the media had been removed from all three filters. During that visit, I was able to go inside Filter 3 to inspect the underdrains.

Photo 1. Denniston WTP Filter Media Removal

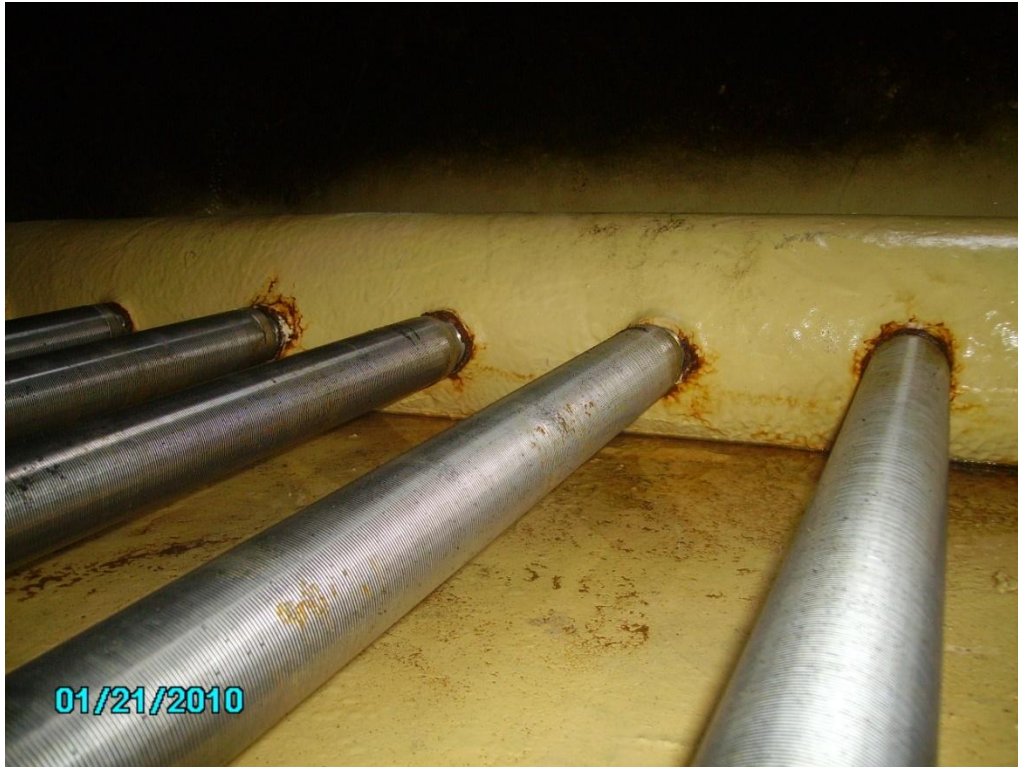
Photo 2 shows the inside of Filter 2 with the laterals still in place. It is apparent that corrosion has been occurring at the connection between the stainless steel wedgewire laterals and the manifold.

This corrosion was cause for concern, but the laterals were still intact, and at that point there were no obvious reasons for loss of media. Inside the building, blind flanges had been removed from the ends of the pipes extending from the underdrain manifolds. As seen in Photo 3, media was found in the manifolds of all three filters.

Photo 2. Corrosion of Steel Manifold at Connection Points of Wedgewire Laterals

Reinstallation of the laterals and repair of the manifold should eliminate the loss of media. However, in doing so, I recommend replacing the manifold piping with stainless steel. The corrosion of the existing steel piping is almost certainly caused by dissimilar metals in contact which creates a galvanic corrosion cell. In this case, the steel will corrode to protect the stainless steel. When the rebuilding was done in 2005, the stainless steel laterals should have been insulated from the steel using plastic bushings or other similar measures. Replacing the steel manifolds with stainless steel and insulating them at the point of connection to the existing piping should prevent such corrosion from happening in the future. This is common practice by other filter manufacturers and other engineers within MWH.

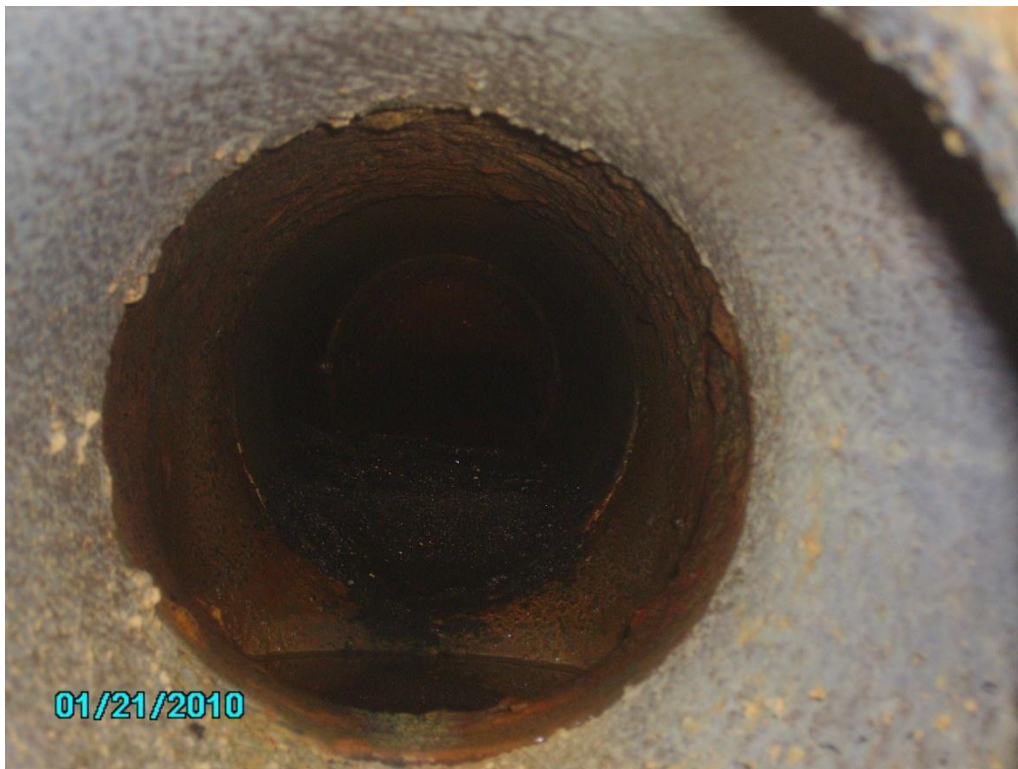
Photo 3. Filter Media Inside Filter Underdrain Manifold Pipe

Based on my review of the filters and the information provided, my conclusion is that the media found in the underdrains most likely came from the loose lateral in Filter 1. This explains the reason that Filter 1 had its backwash rate reduction prior to the other filters. Over time, media made its way into the filtered water pipe and then was forced back to the other filters while backwashing. See Photo 6 for the pipe configuration of the filter effluent and backwash supply. This would also explain why Filter 3, the closest to the backwash supply pipe, was the second filter to experience reduced backwash flow.

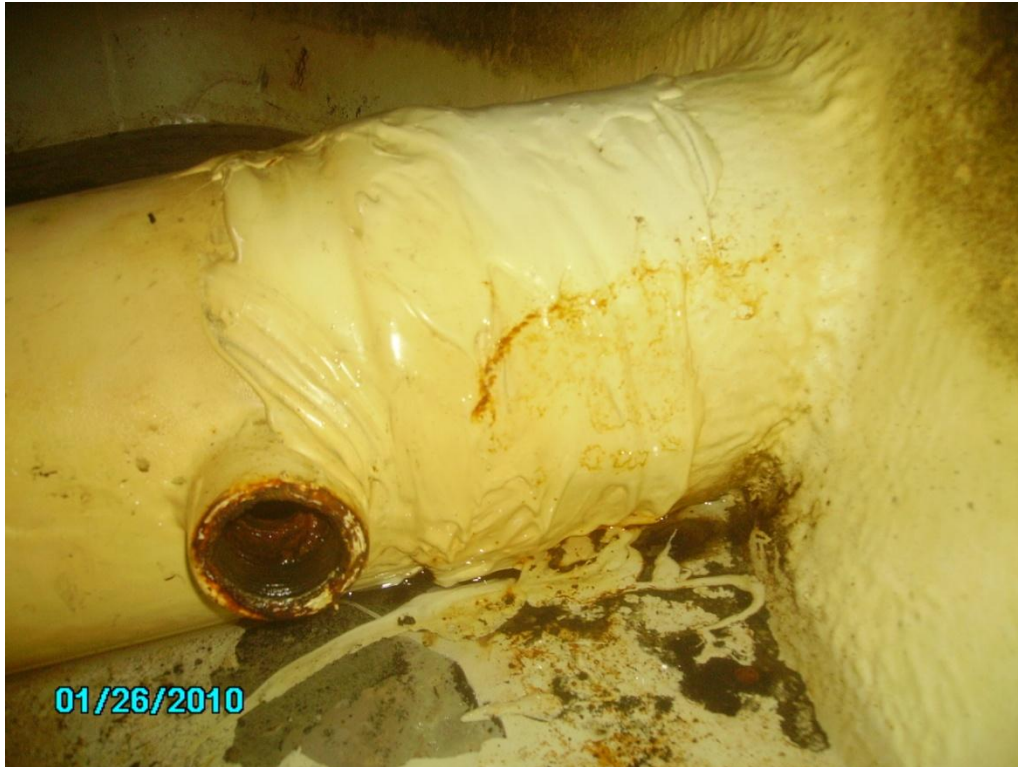
Prior to my second visit to the plant, ERS had found one of the laterals in Filter 1 had come loose. Subsequently, after removing the media and laterals, all the laterals were replaced by plugs, and the filters were pressure tested. A crack in the Filter 1 manifold was found at the location where the new pipe installed in 2005 was welded to the old pipe. See Photo 4.

Photo 4. Location of Crack in Filter 1 Manifold Pipe

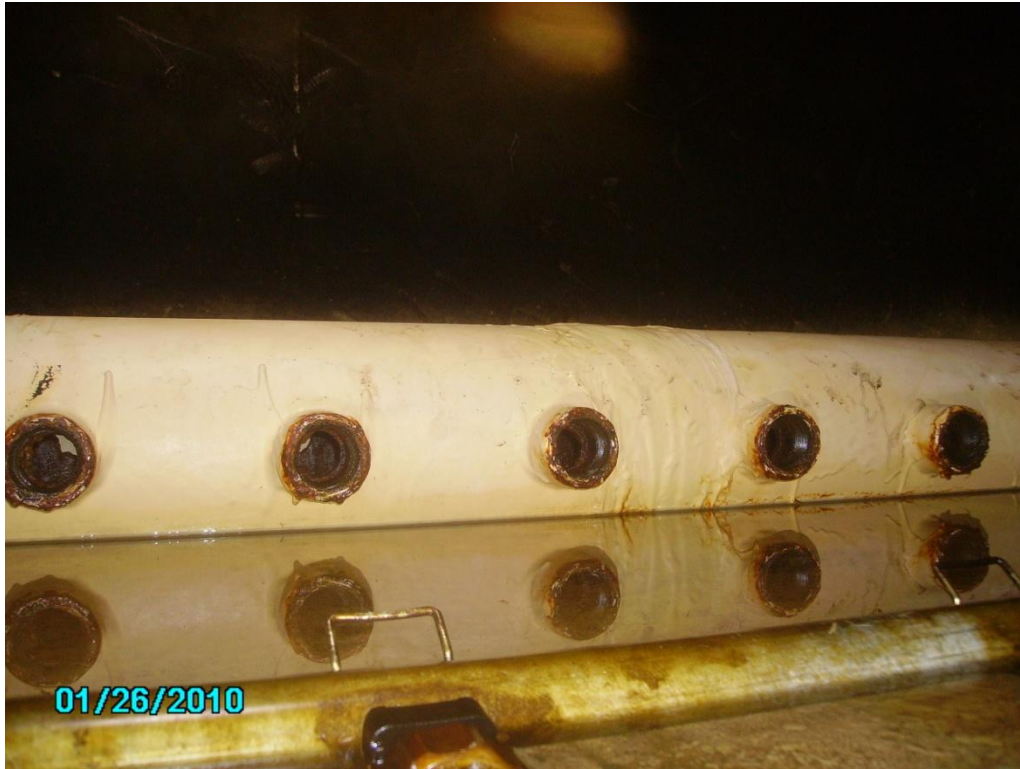
During the second visit, I was also able to view the condition of the manifolds at the connections to the laterals and found that they were all severely corroded. See Photo 5. This confirmed my concern from the initial visit.

Photo 5. Rusted Lateral Connections in Filter 3
