Alves Water Tank

Coastside County Water District
Half Moon Bay, CA

Structural Review and Retrofit Strategy Report

May 29, 2018

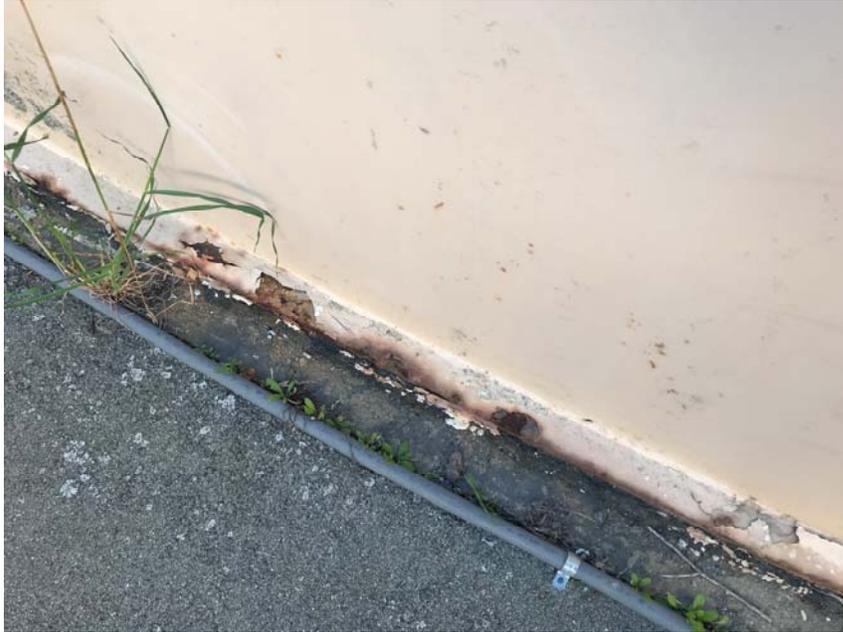
- Corrosion of the bottom plate is evident in various locations along the perimeter of the tank, see photo 1.
- Corrosion is evident on the exterior tank shell at various locations around the tank, see photo 2.
- Localized areas of minor corrosion are evident on the tank roof, see photo 3.
- The caulking along the top of the footing and the tank bottom plate has degraded and is starting to pull away leaving localized gaps between the footing and bottom plate, see photo 4.
- Corrosion is evident around the perimeter of the roof vent, see photo 5.
- Corrosion is evident on the roof hatch with two small holes visible in the hatch door, see photo 6.

Photo 1: Corroded Tank Bottom Plate

- Areas of localized rust and corrosion upon interior framing members, roof plate, and roof hatch should be cleaned and inspected during scheduled painting and maintenance. If more than 10% of the section is lost, then a repair detail should be developed. Roof hatch door should be replaced.
- Areas of localized rust and corrosion on the tank bottom plate should be cut out and patched with new segments of floor plate if corrosion extends inside the tank. Further investigation of the corrosion on the floor slab should be conducted to determine extents.
- Caulking along the top of the footing should be repaired/ replaced as necessary to close off localized gaps between the footing and the bottom plate.

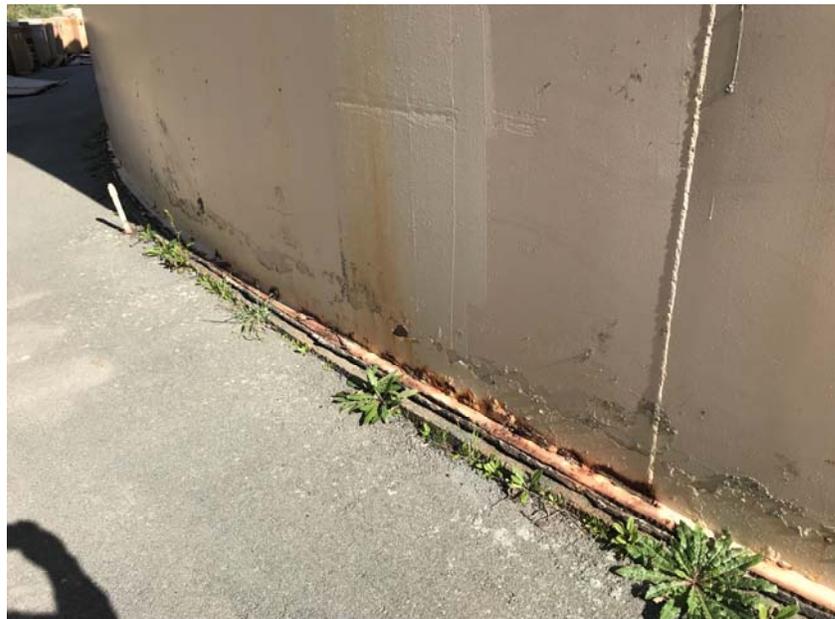
Photo 2: Corrosion on Tank Shell Plate

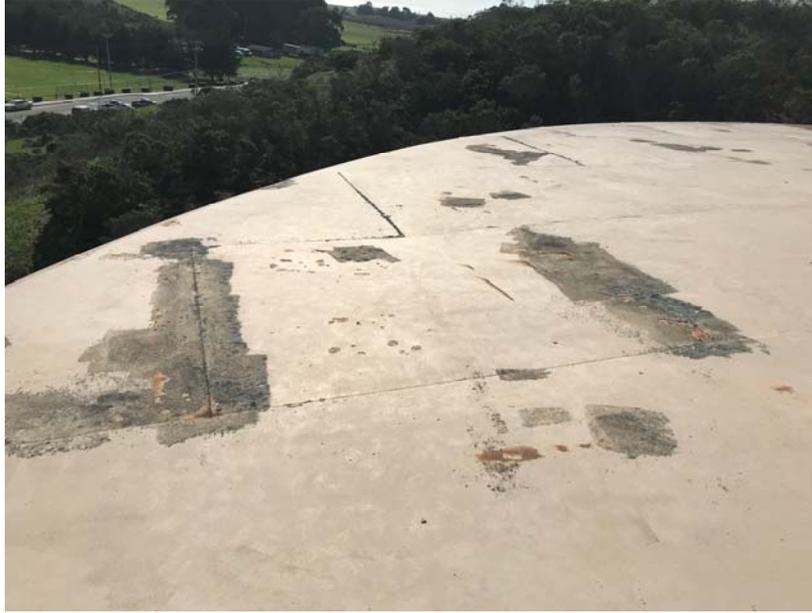
Photo 3: Corrosion on Tank Roof Plate

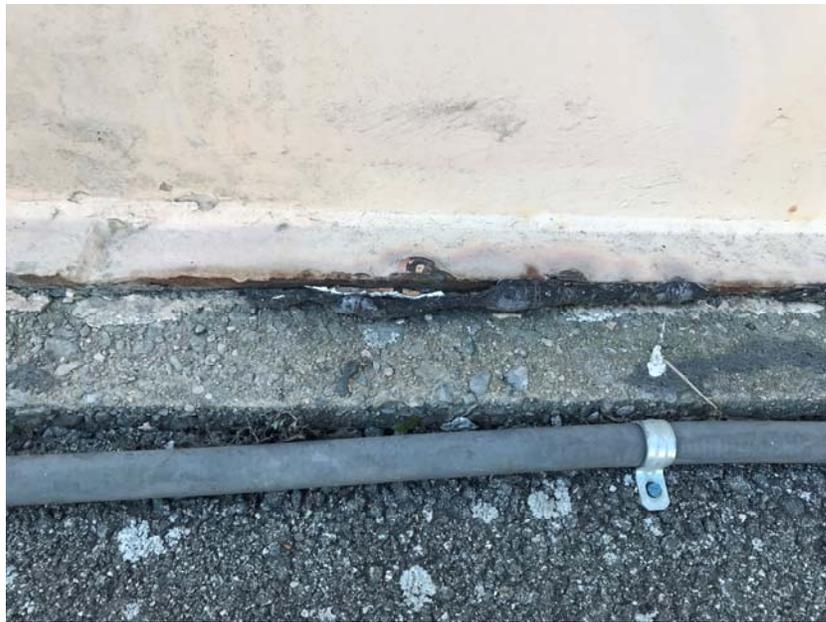
Photo 4: Degraded Caulking along Perimeter of Bottom Plate

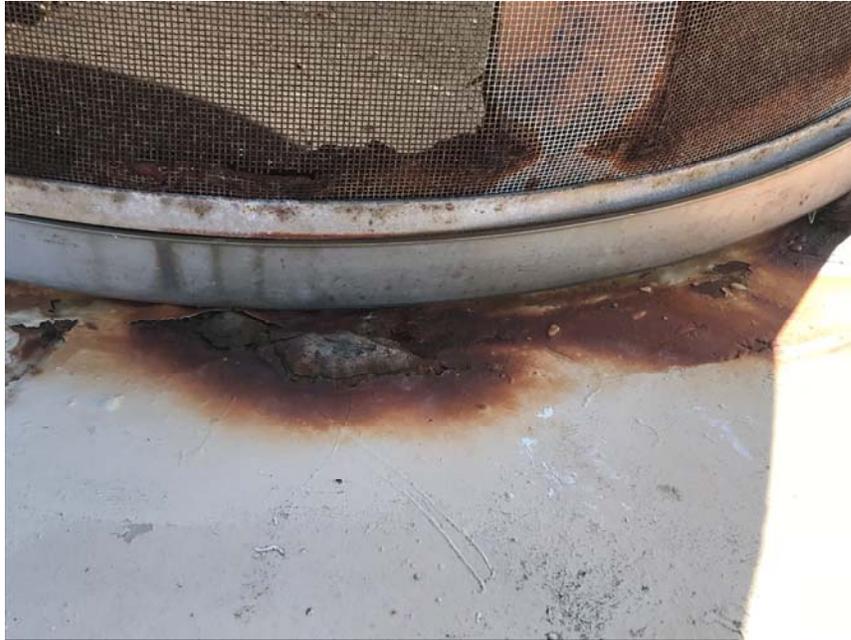
Photo 5: Corrosion around Perimeter of Roof Vent

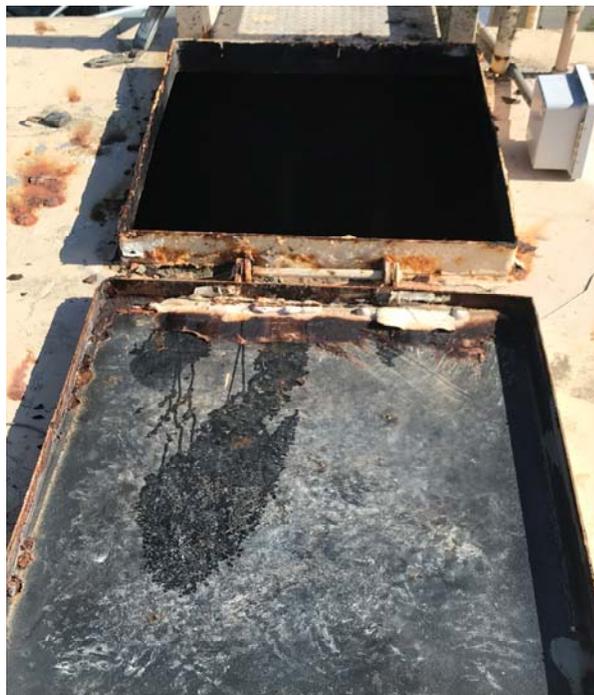
Photo 6: Corrosion on Roof Hatch

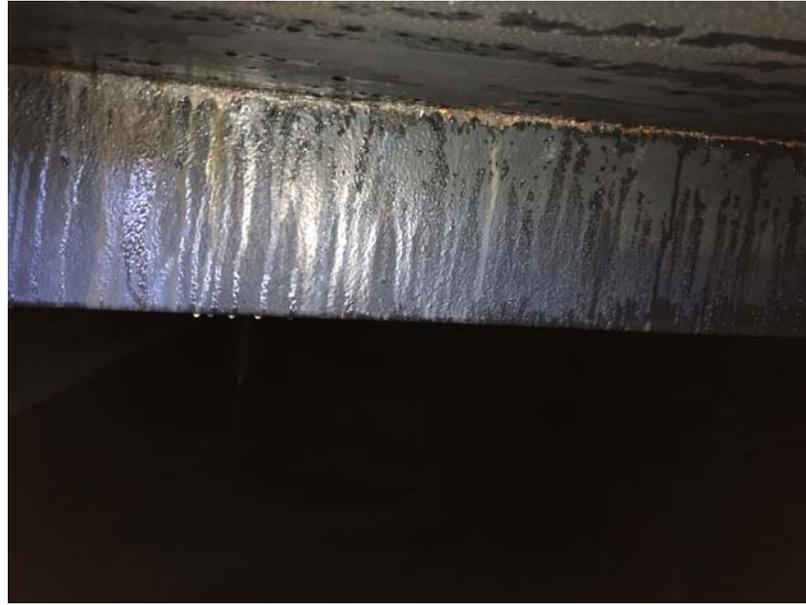
Photo 7: Condition of Existing Exterior Rafters

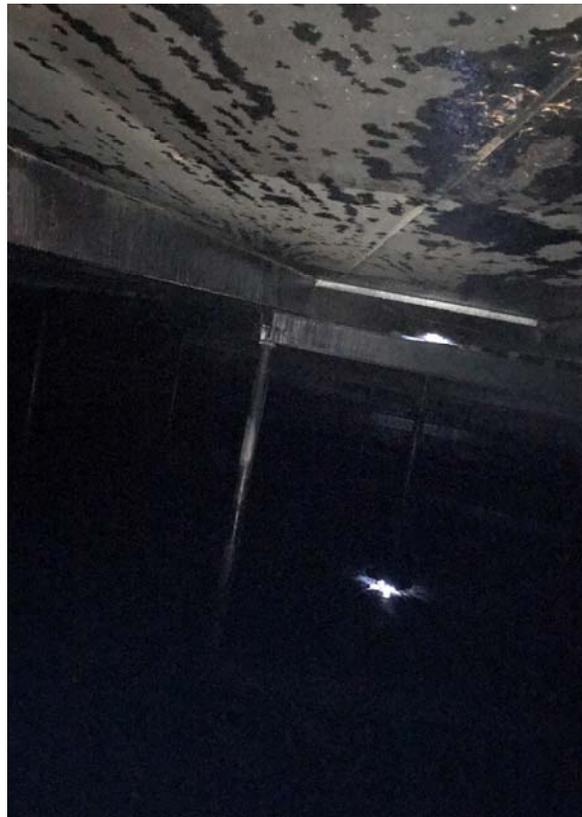
Photo 8: Existing Roof Framing

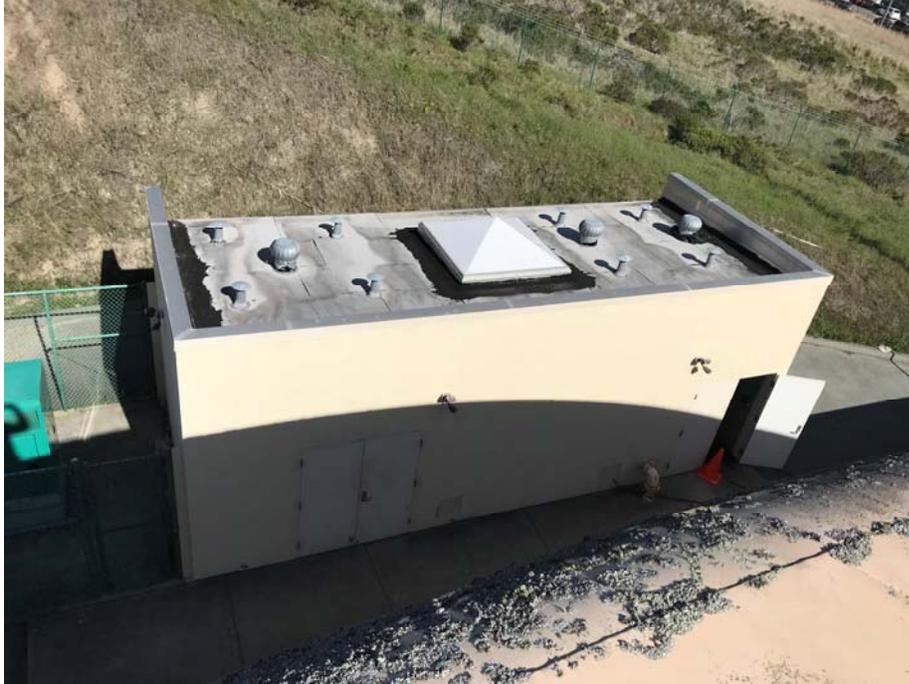
The pump house is anticipated to perform below average in comparison to buildings of similar construction when subjected to a design level earthquake due primarily to the assumed inadequate roof-to-wall ties.

Photo 9: Pump House Building

Based on our Tier 1 investigation summarized in section 3.5 above, it is likely that the roof-to-wall ties are either missing or are inadequate for the current seismic design codes. Removal and reinstallation of the ceiling will be required to install the new ties. Roof to wall ties will consist of tension tie rods drilled and epoxied through the existing masonry walls with holdown anchors installed on the sides of the roof joists. At locations where walls are parallel to the roof framing tension tie rods shall be installed through blocking in the outer 3 bays of framing with metal straps installed on top of the roof. Enhanced nailing on the roof sheathing will be required at the location of the tie rods. Removal and reinstallation of the roofing and ceiling has been included in the cost estimate as rough order of magnitude costs. Additional work to the roof diaphragm (plywood sheathing, additional nailing) may be required depending on what type of roof sheathing exists on

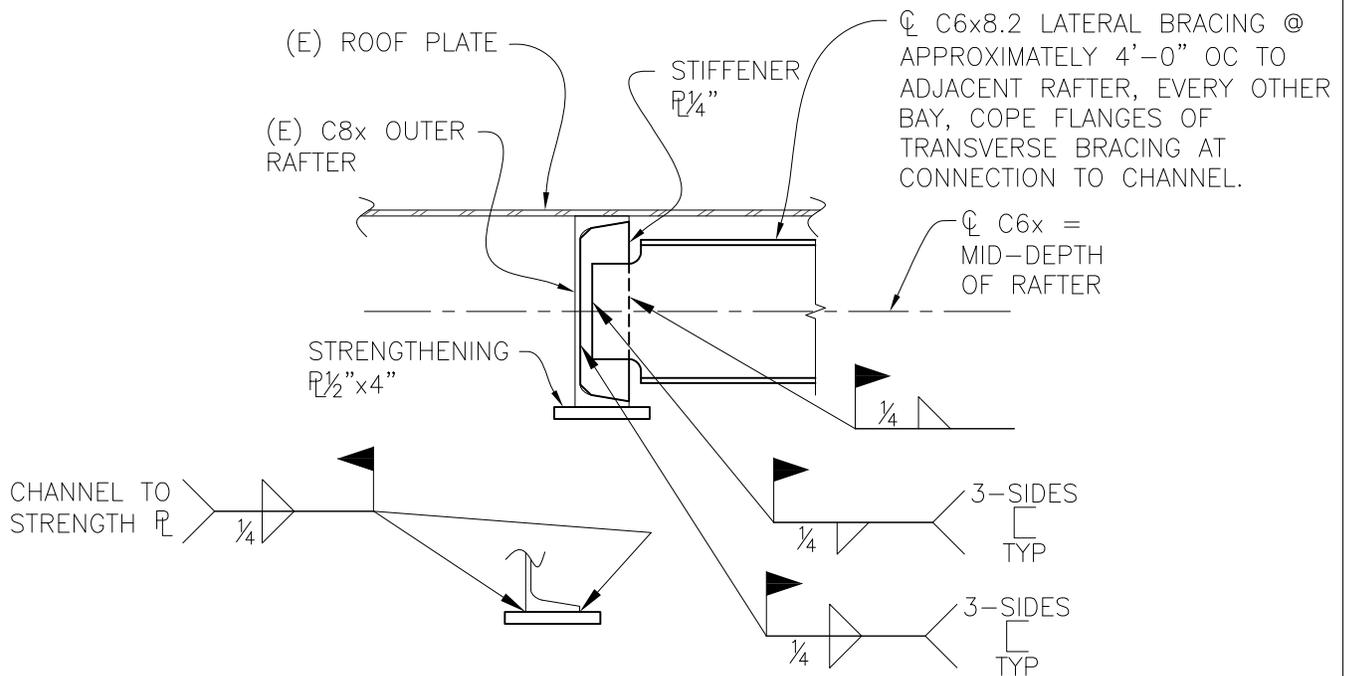
A
SK-1

OUTER BAY RAFTER STRENGTHENING

- The outer bay roof rafters will require strengthening of bottom flanges by welding on steel plates and bracing the bottom flange with transverse members (See concept Detail A shown in Sketch 1 of the Appendix). The roof plate can adequately resist these forces if the roof plate is welded to the roof rafters or by potentially installing slider clips that would be connected to the underside of the tank roof and hang underneath flanges of existing rafters. According to the available shop drawings, existing roof plate is welded to transverse angle brace and not each rafter. Conditional evaluation after blast cleaning may warrant full replacement of the outer rafters as a more economical solution.
