Appendix A
PILARCITOS INTEGRATED WATERSHED MANAGEMENT PLAN
WATERSHED ASSESSMENT UPDATE

**Pilarcitos Integrated Watershed Management Plan
Watershed Assessment Update**

Philip Williams & Associates, Ltd.

September 29, 2008

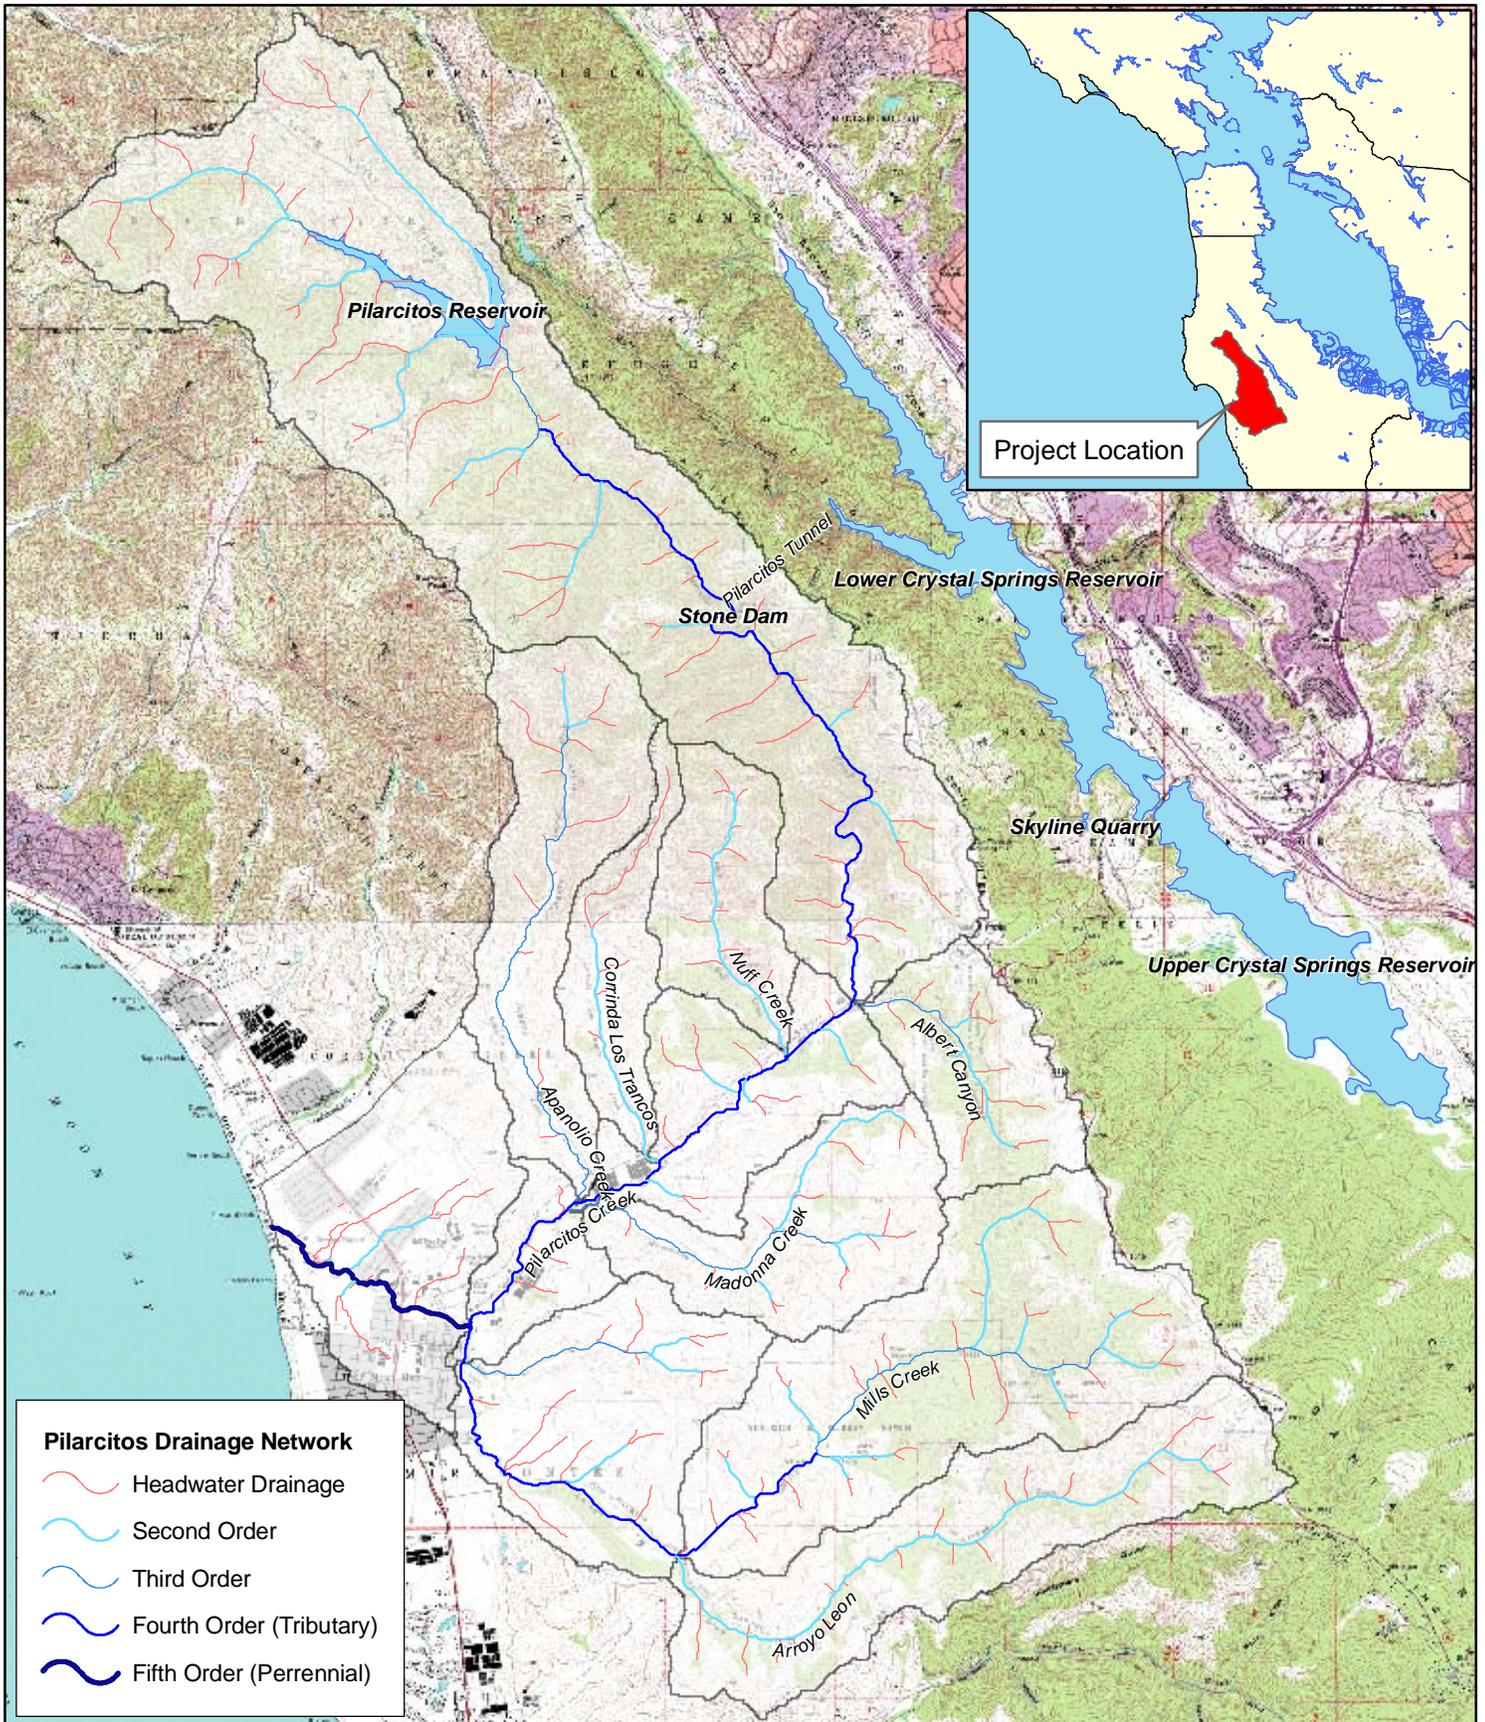
figure 1

Pilarcitos IWMP
 Pilarcitos Drainage Network

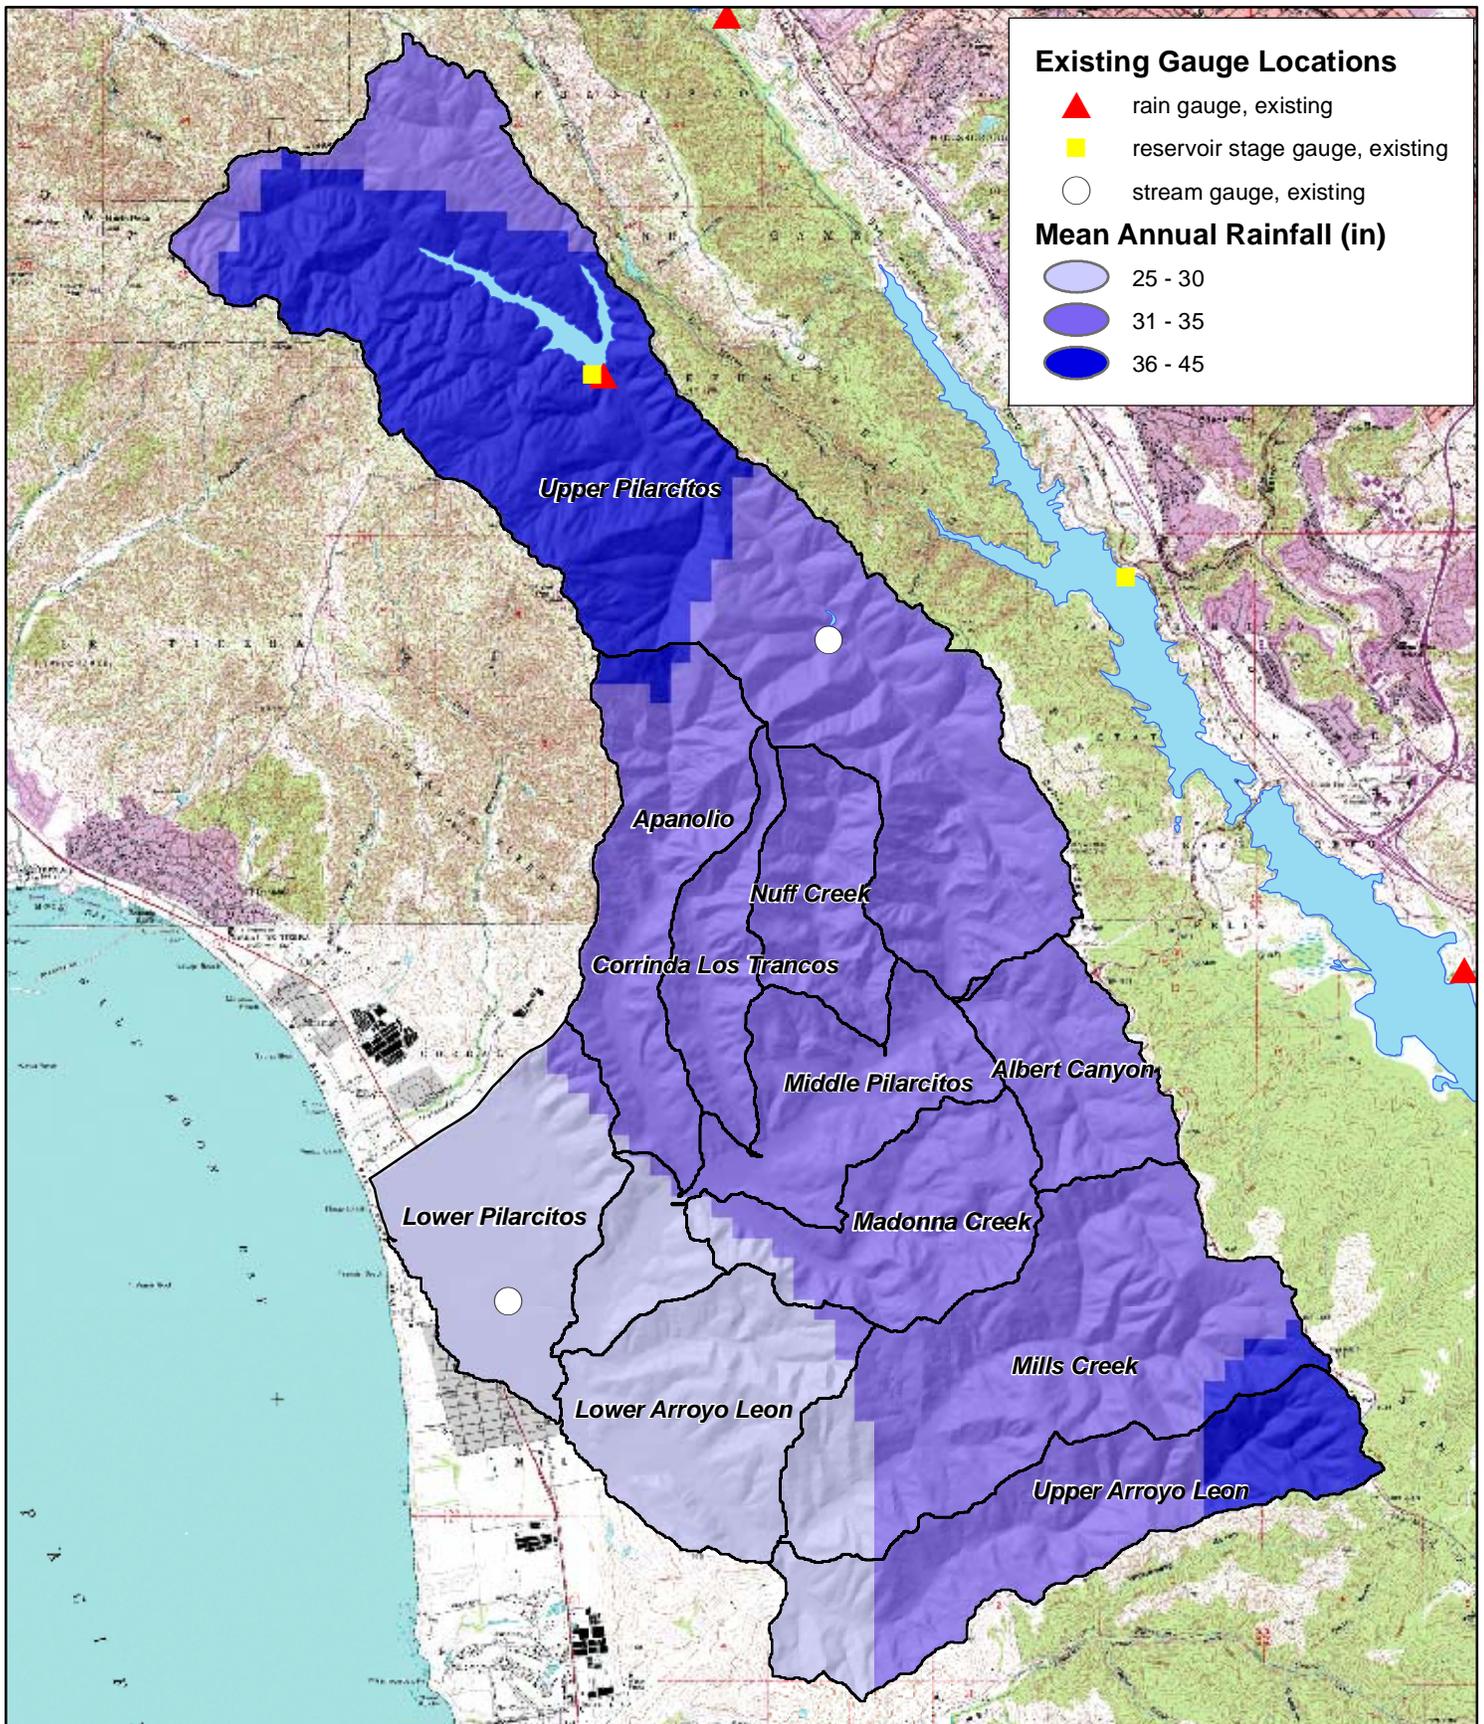
figure 2

Source: USGS (quadrangle, dem), USDA (rainfall PRISM,2005), SPUC (water bodies, gauges locations)

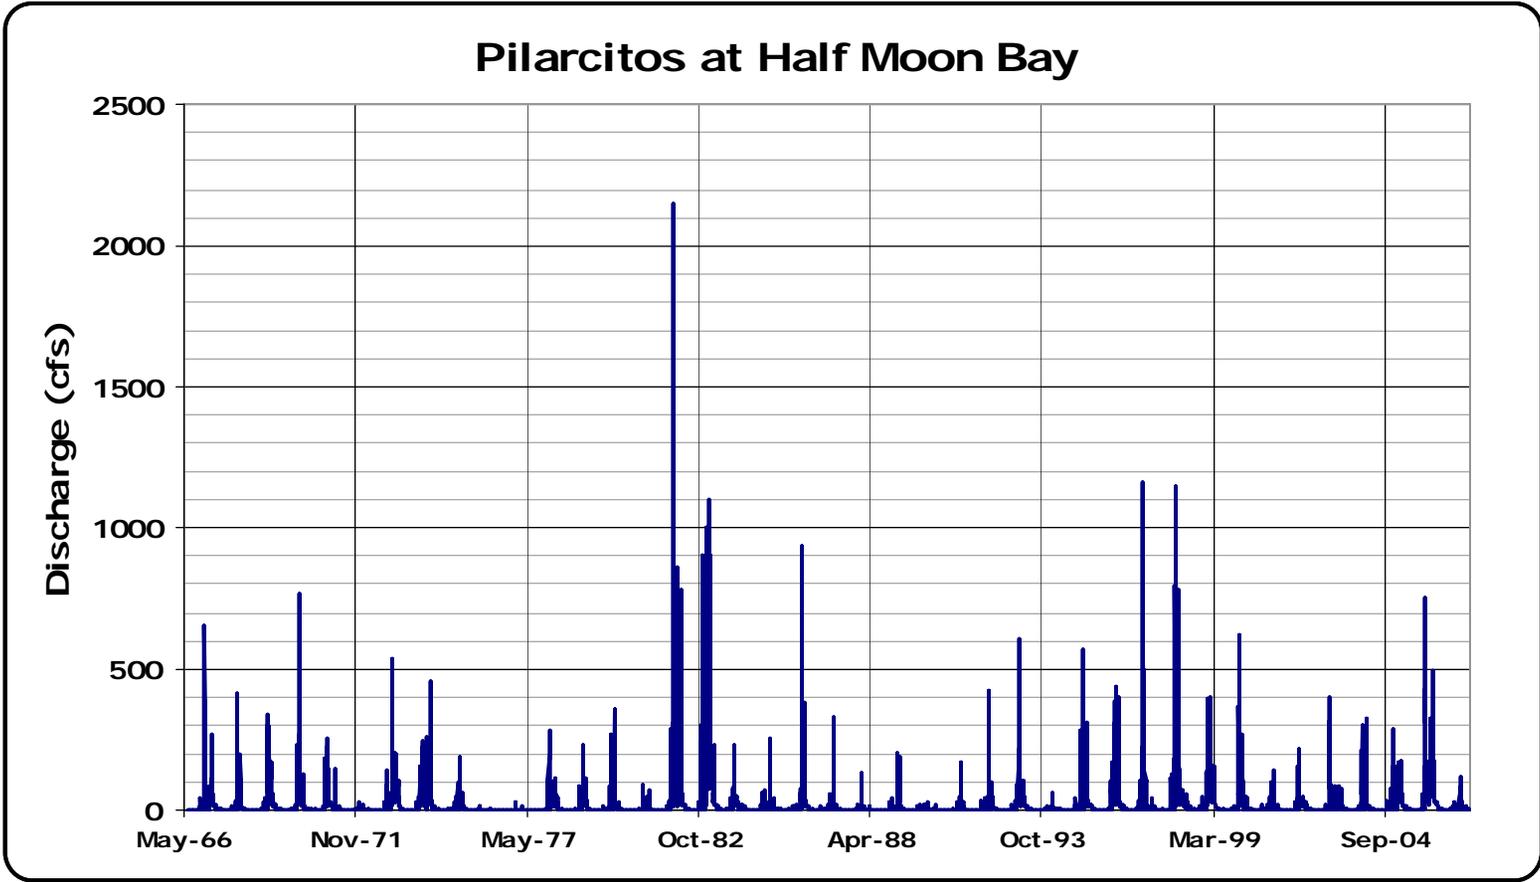
figure 7
 Pilarcitos IWMP

Notes: USGS Station (11162630)
 Source: Sound Watershed Consulting

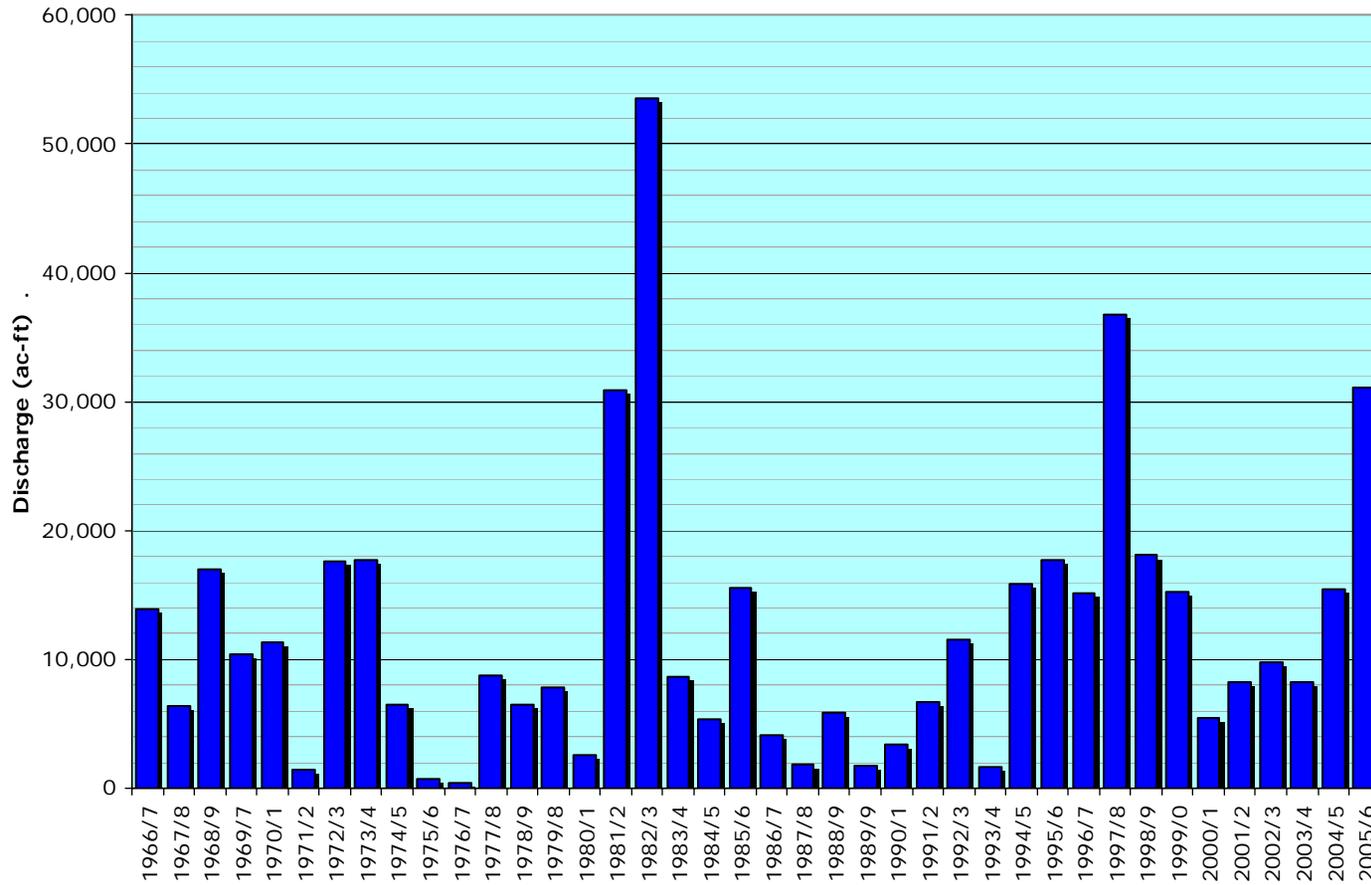
figure 8
Pilarcitos IWMP

Total Annual Discharge at Half Moon Bay

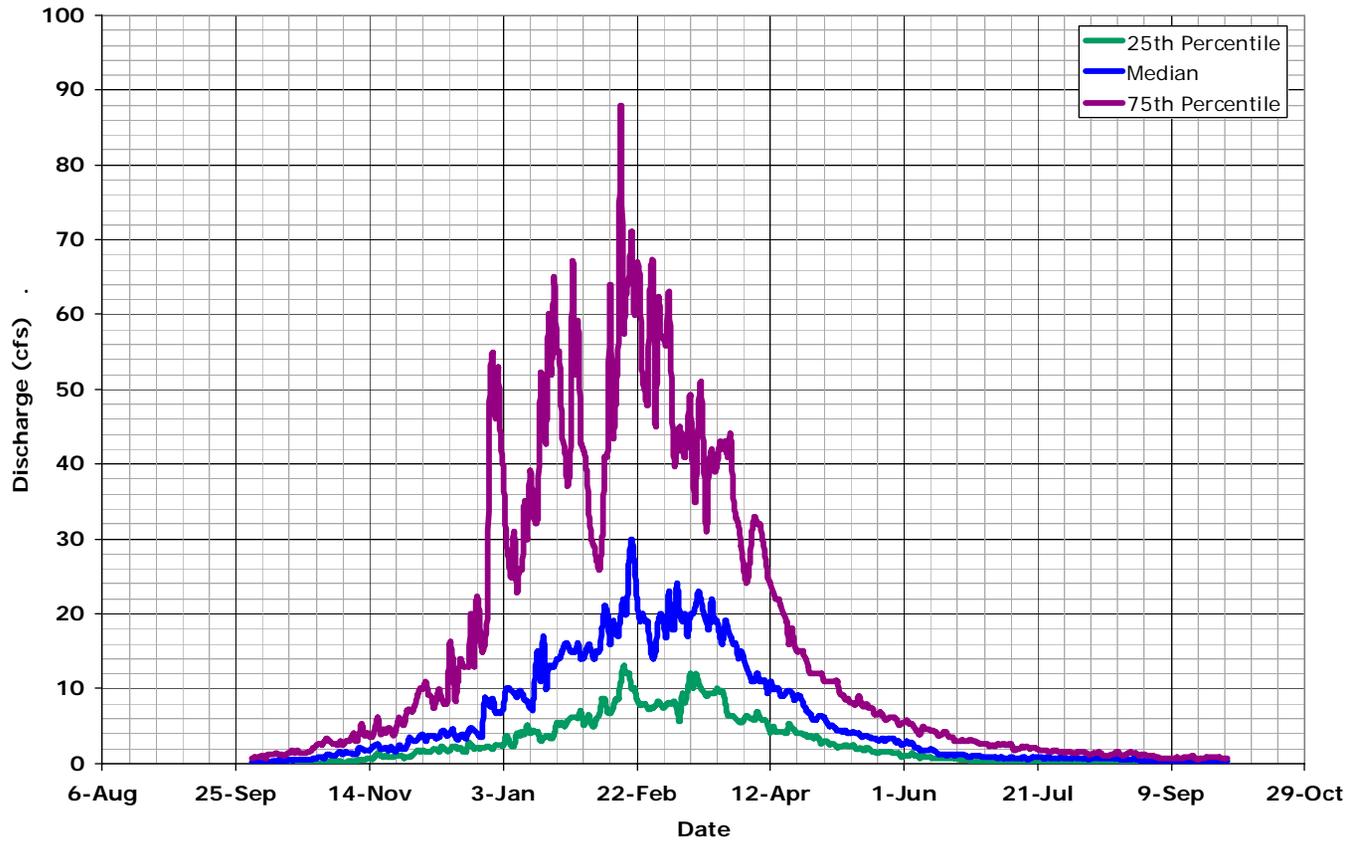
figure 9
 Pilarcitos IWMP

Pilarcitos at Half Moon Bay

Notes: Annual hydrograph represents the typical conditions over the period of record. Flows below the 25th percentile typically indicate drought periods, while flows above the 75th percentile are typically considered unusually wet years.
 Source: Sound Watershed Consulting

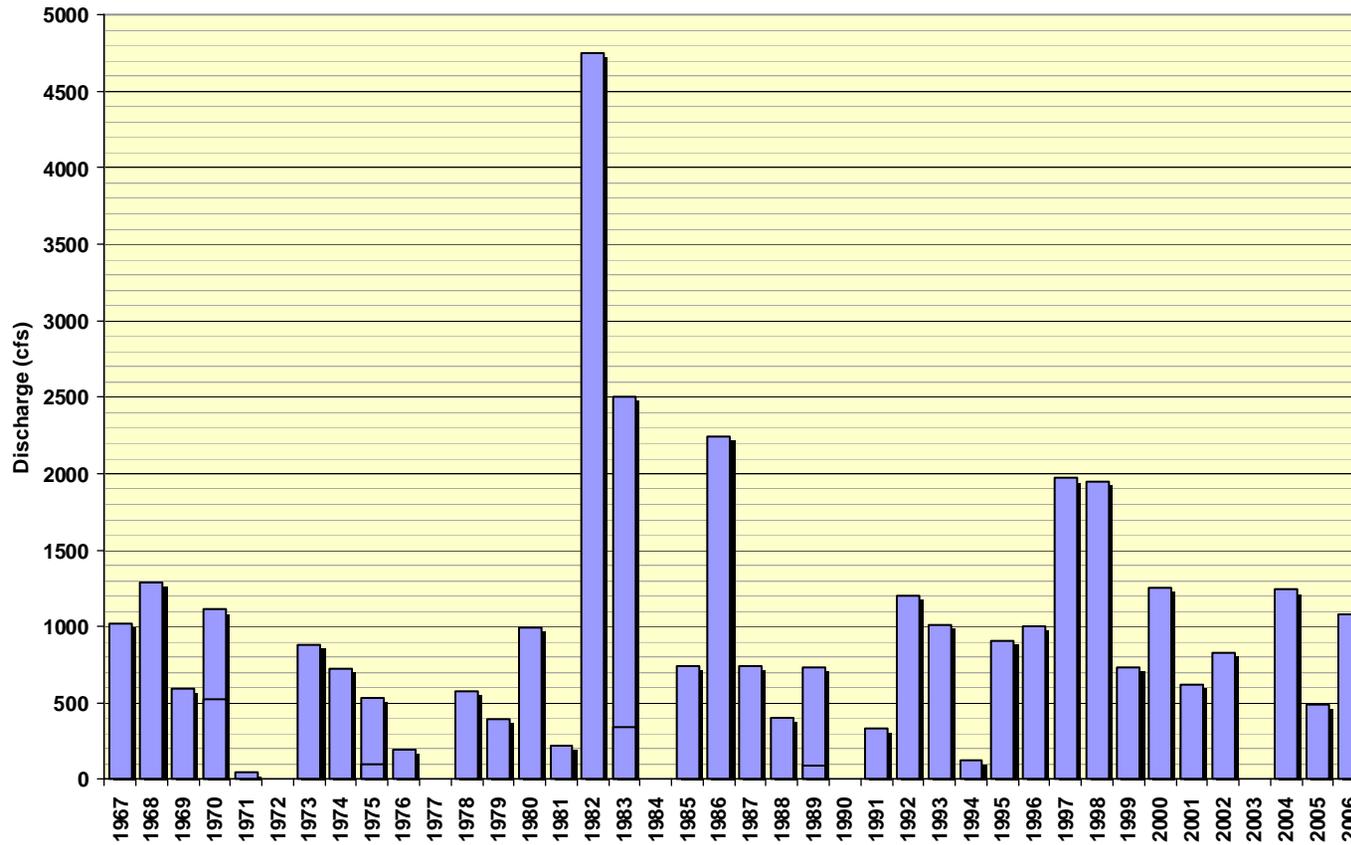
figure 10
Pilarcitos IWMP

Peak Instantaneous Discharge

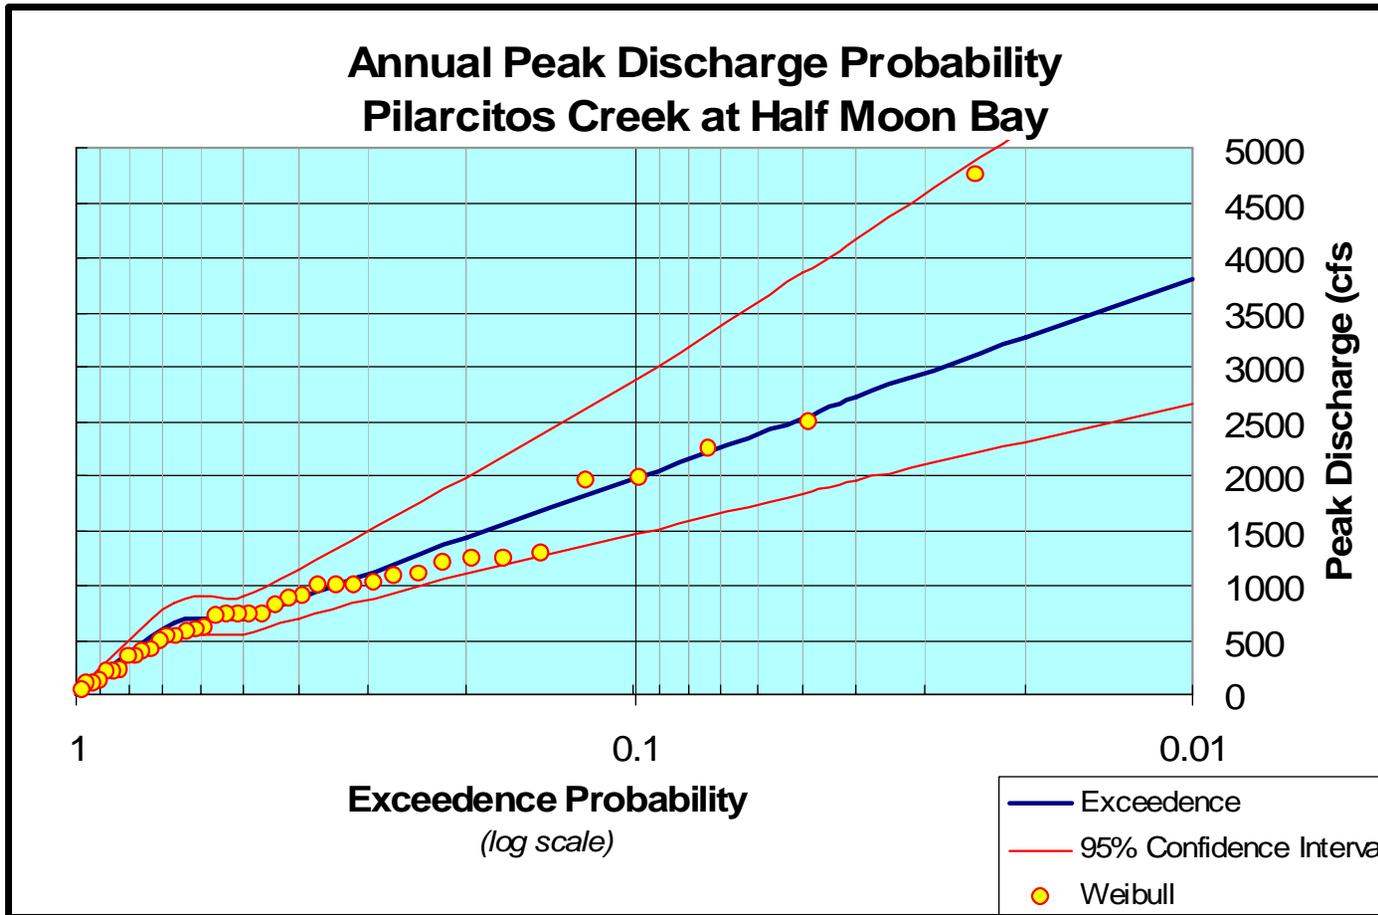
figure 11
Pilarcitos IWMP

- Figure 10. Peak Instantaneous Discharge at Half Moon Bay
- Figure 11. Peak Annual Discharge (Log Pearson III)
- Figure 12. Annual Days with Zero Recorded Flow at Half Moon Bay

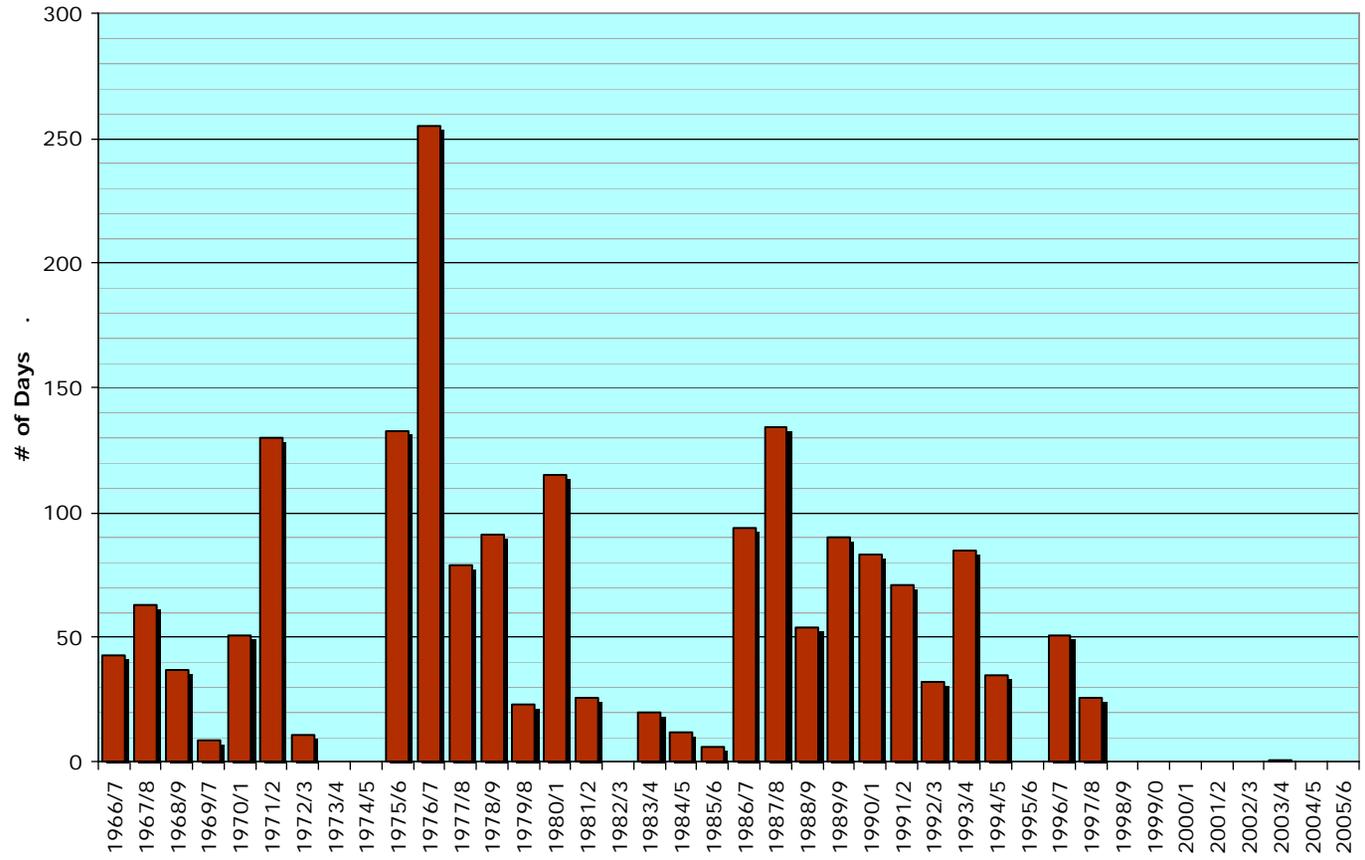
figure 12
Pilarcitos IWMP

Total Days of No Discharge

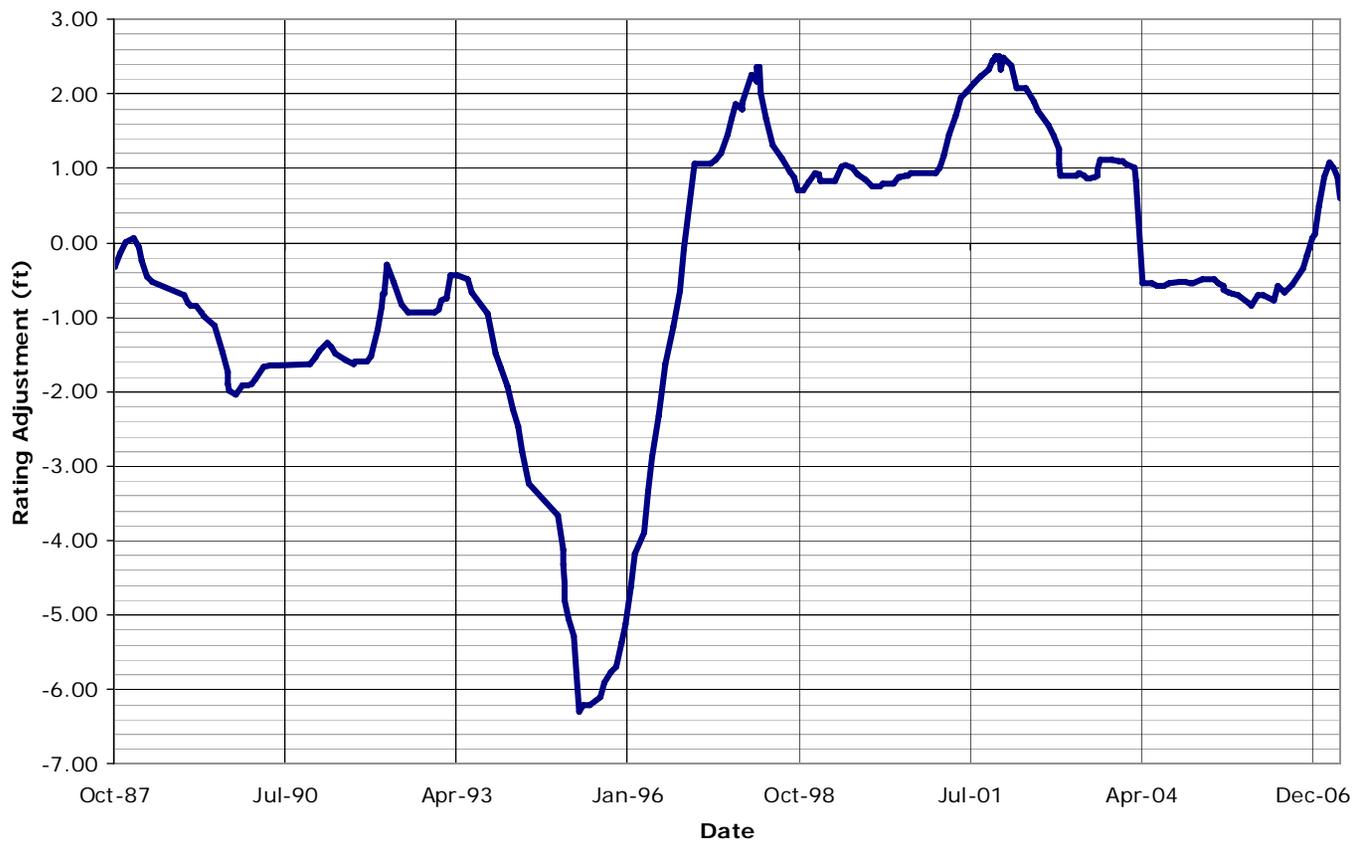
figure 14
Pilarcitos IWMP

Cumulative Rating Curve Shift Adjustment

Notes: USGS station (11162630) measurement data. Plot indicates channel changes near the gage location that influence gage
 Source: Sound Watershed Consulting

The USGS has rated the stream gage below Stone Dam as “poor,” which implies that the hydraulic control at the stream gage location is significantly dynamic. This may be in part due to the very low quantity of discharge and the relatively small channel that can dramatically limit the accuracy of streamflow measurements. The existing rating curve for peak discharges (Figure 17) indicates that flows rarely exceed a stage of two feet. Observed shifts in the rating curve (Figure 17) suggest chronic aggradation prior to December 2002 when a significant channel change occurred (most likely a large deposit of sediment or debris). Based on the rating curve, the channel appears to have naturally recovered from this disturbance by October 2004 and has been relatively stable since.

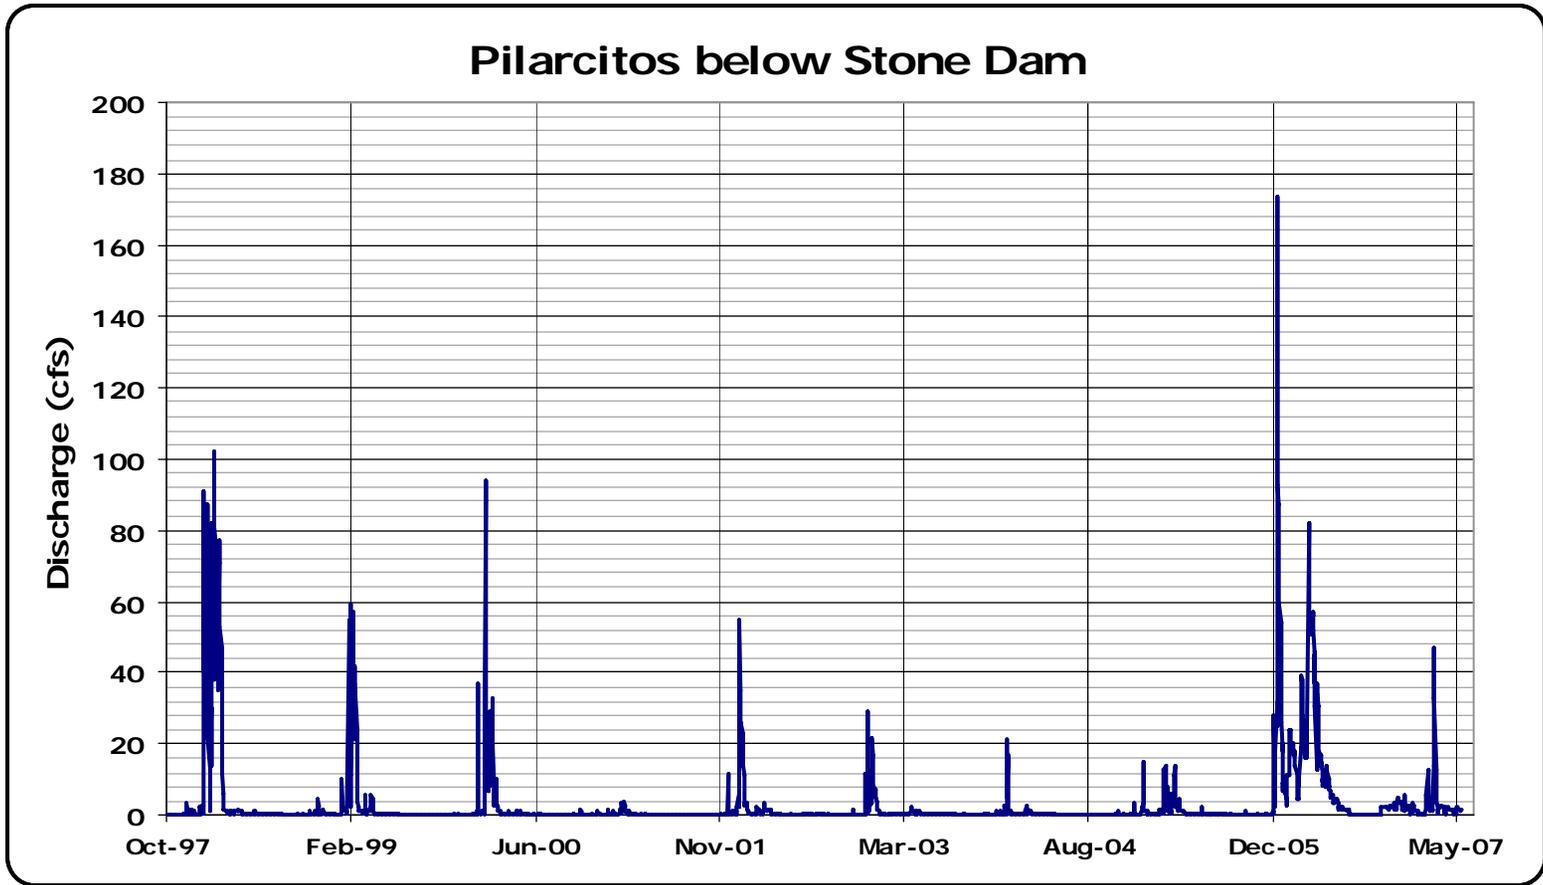
figure 15
Pilarcitos IWMP

Notes: USGS station (11162620)
 Source: Sound Watershed Consulting

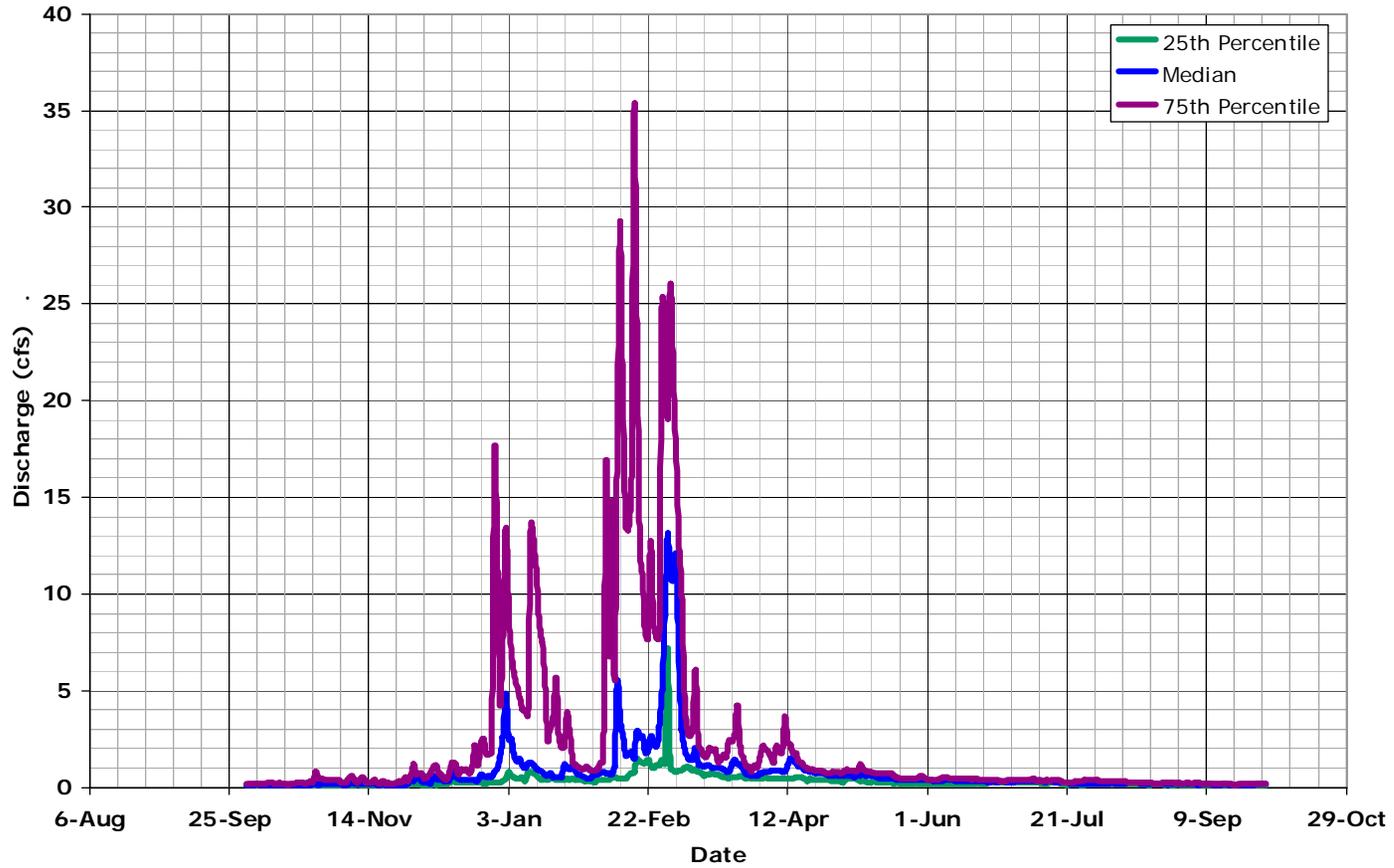
figure 16
Pilarcitos IWMP

Pilarcitos Below Stone Dam

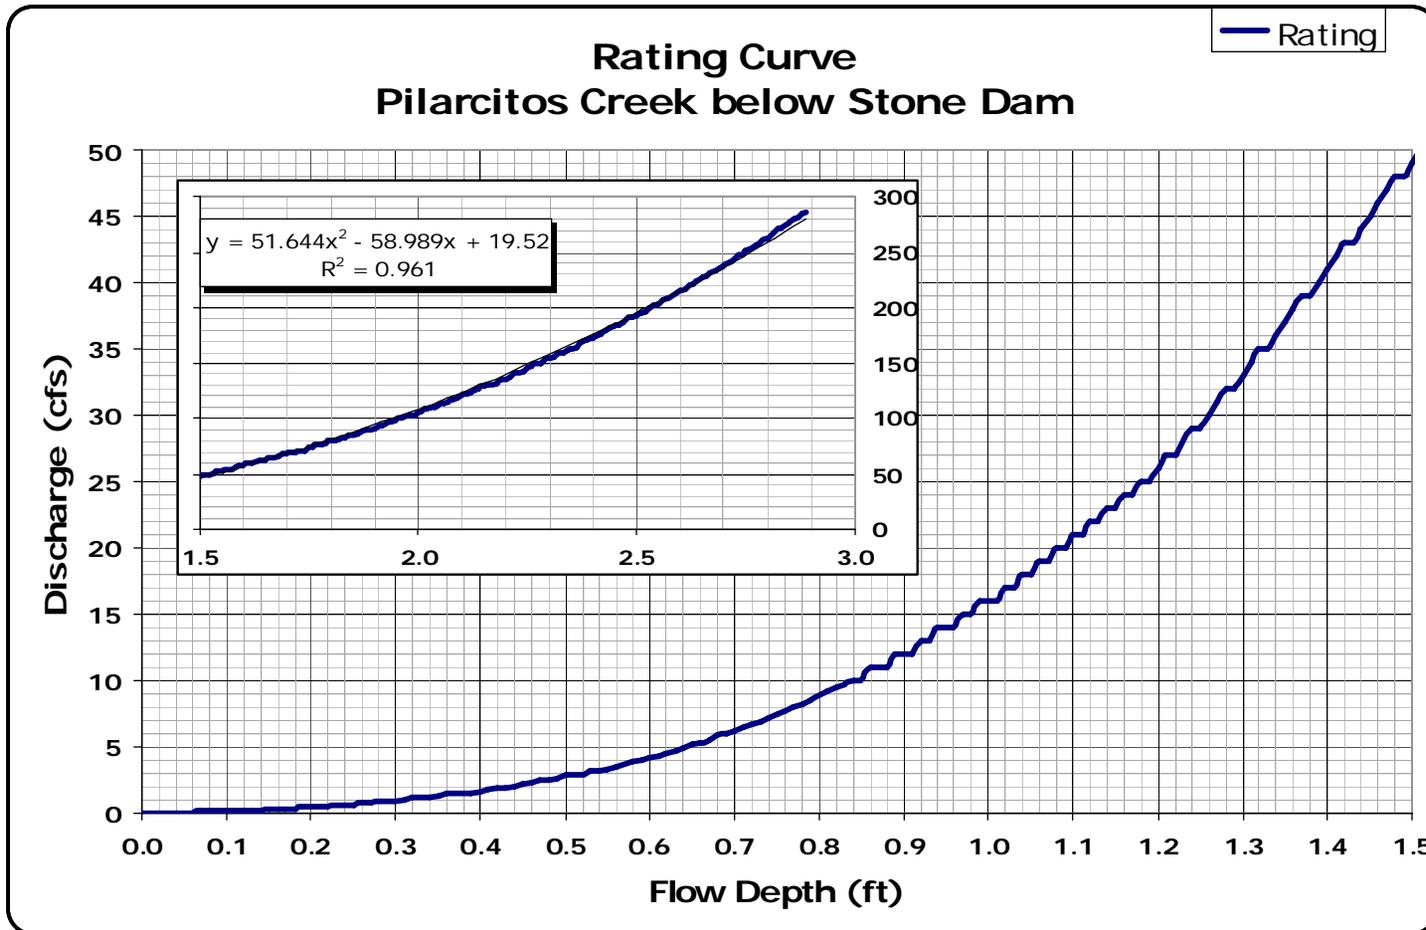
figure 17
Pilarcitos IWMP

Notes: USGS gage 11162620 rating data
Source: Sound Watershed Consulting

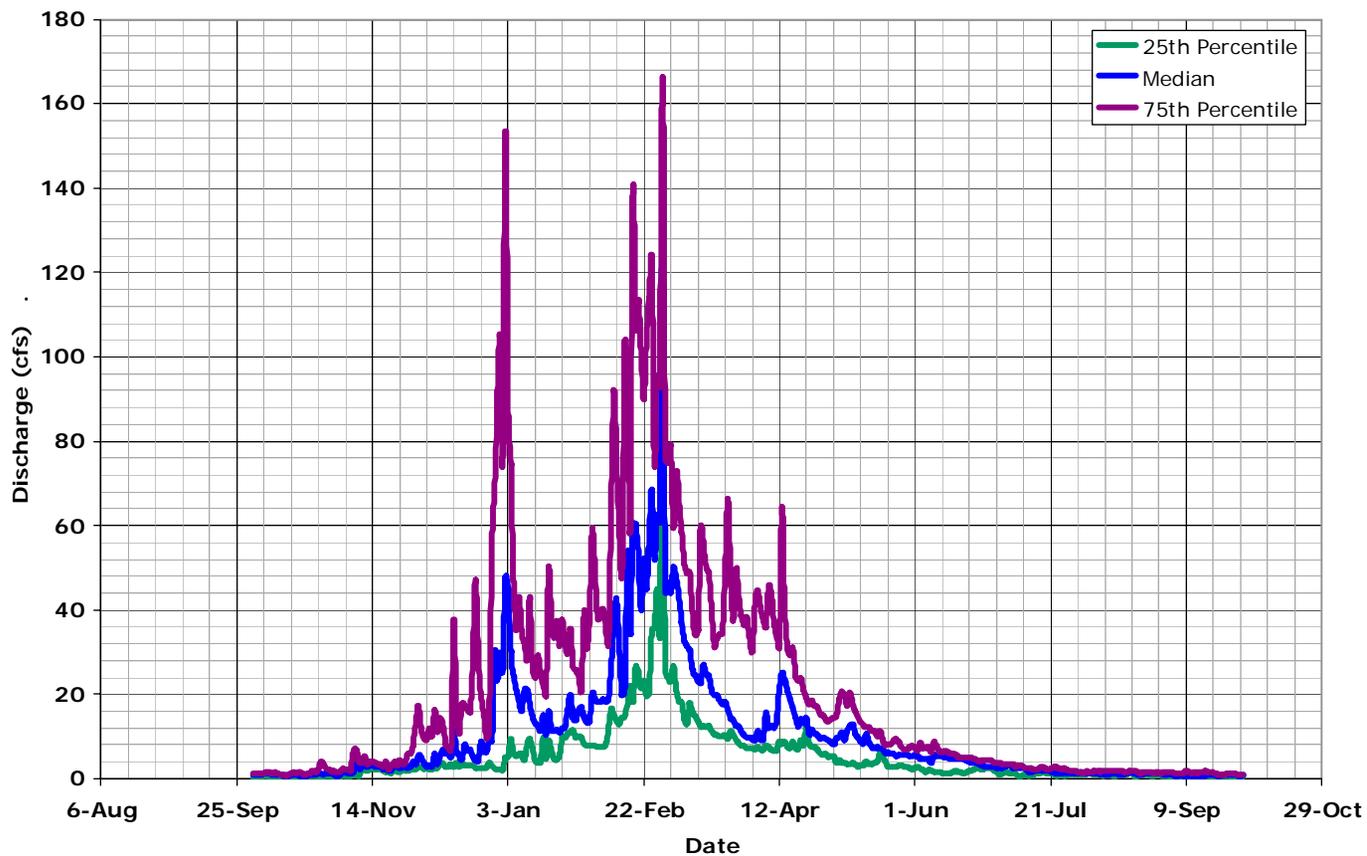
figure 18
Pilarcitos IWMP

Streamflow Gain Below Stone Dam

Notes: from USGS gage data. Note period of record differs from period in Figure XX (Pilarcitos Hydrograph at HMB).
 Source: Sound Watershed Consulting

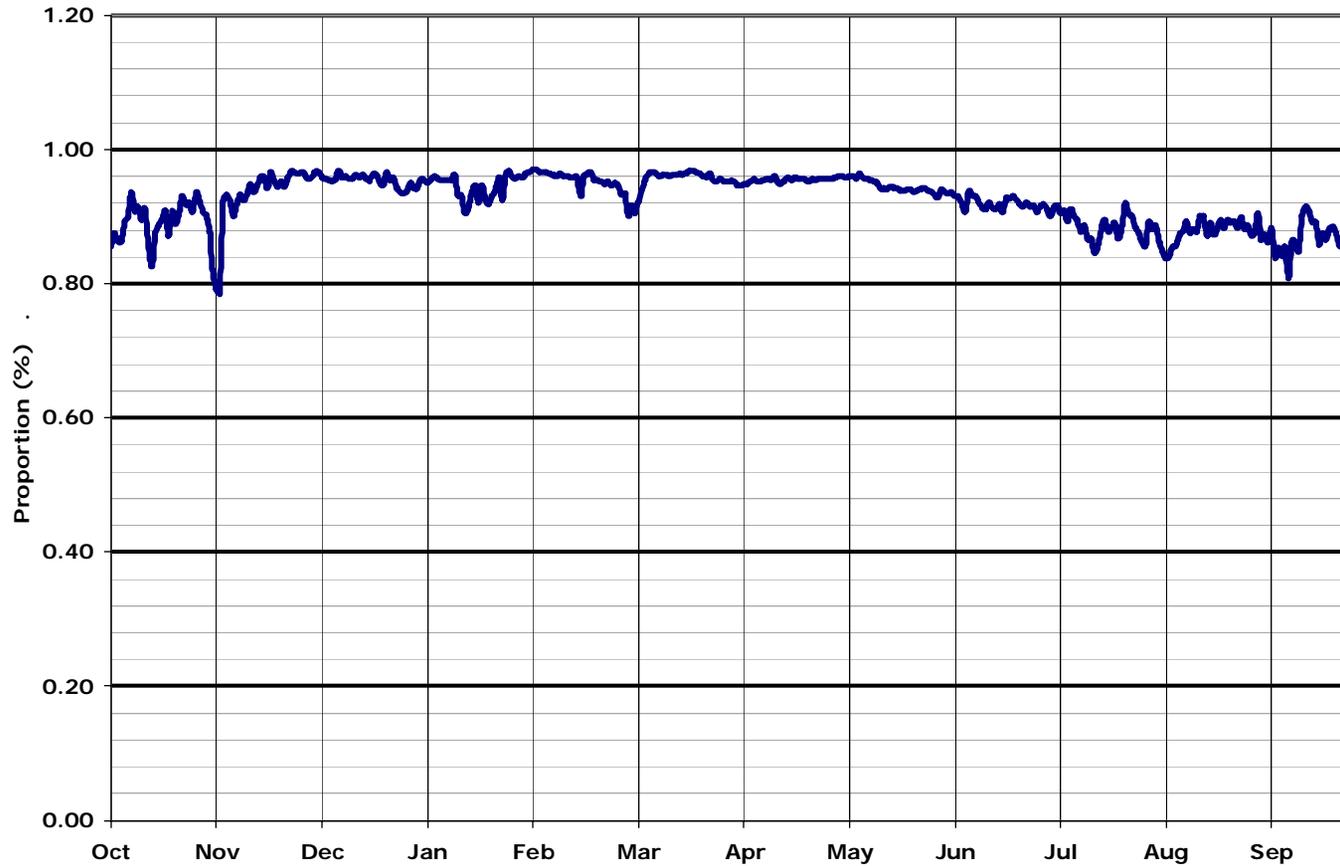
figure 19
 Pilarcitos IWMP

Proportion of Flow at Half Moon Bay from Lower Watershed

Notes: lower watershed includes all contributing area below Stone Dam.
 Source: Sound Watershed Consulting

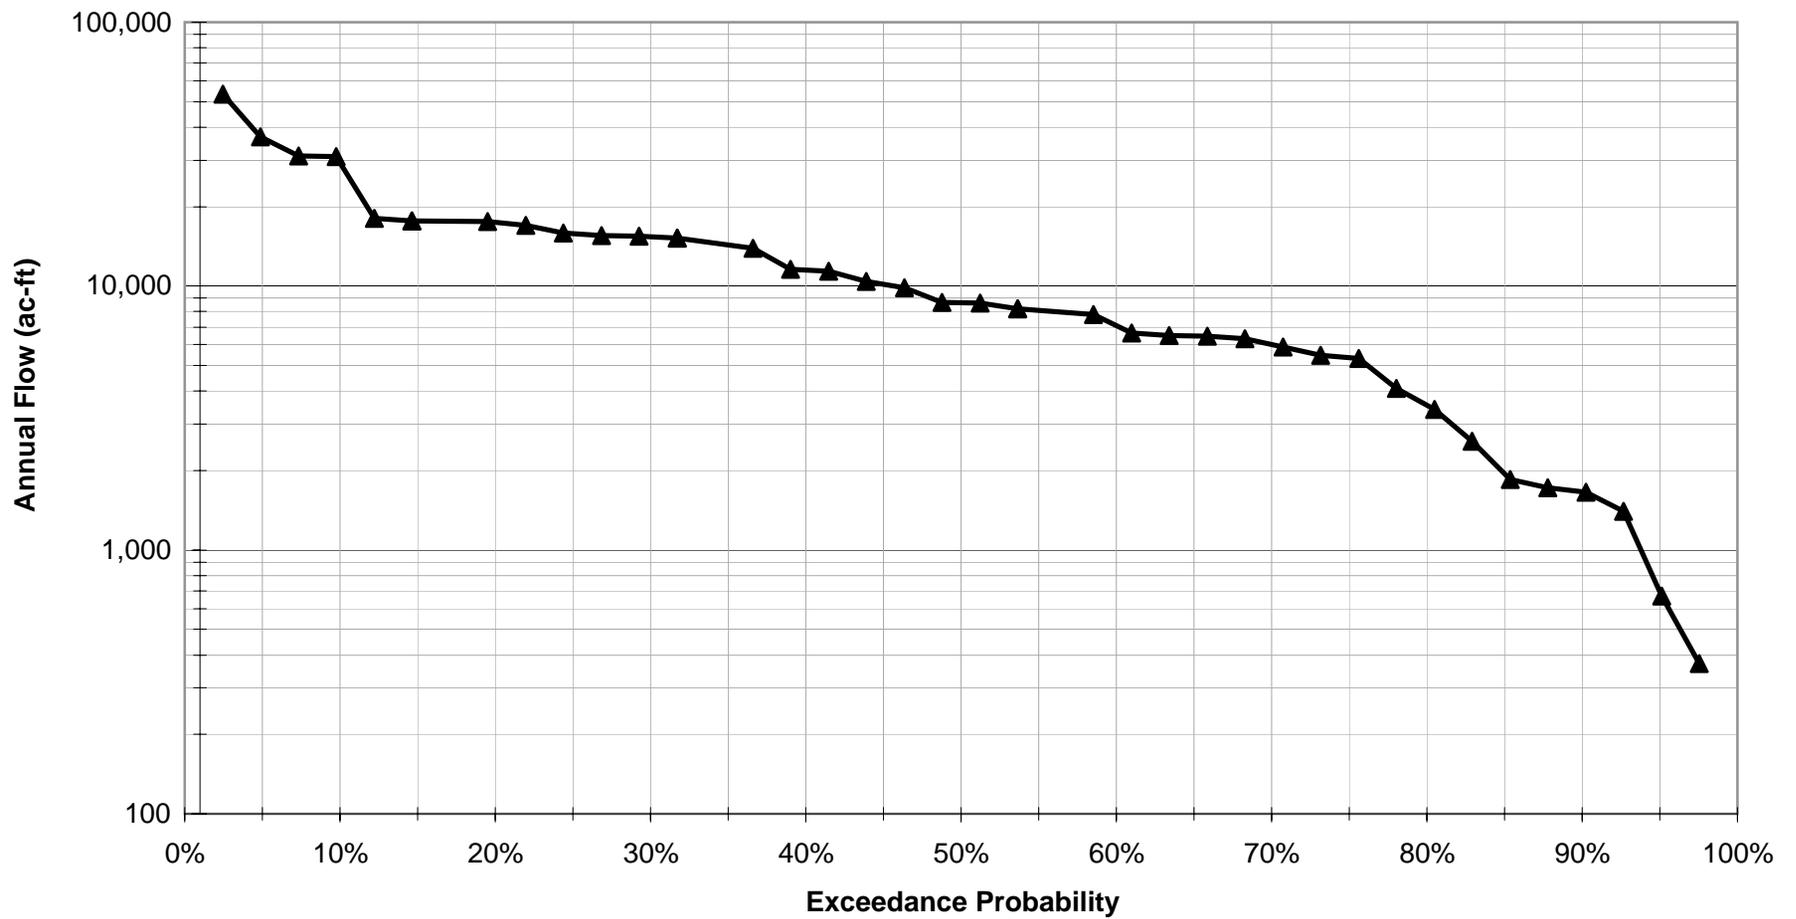
figure 20
Pilarcitos IWMP

Annual Flow Exceedance Pilarcitos at Half Moon Bay

The watershed below Stone Dam is a significant contributor to flows in Pilarcitos Creek at Half Moon Bay (Figure 18, Figure 19, and Figure 20). Anecdotal reports suggest that Apanolio and Arroyo Leon also contribute significant flows to the lower watershed, though the former subwatershed is not large relative to the other subwatersheds.
