Appendix A
PILARCITOS INTEGRATED WATERSHED MANAGEMENT PLAN
WATERSHED ASSESSMENT UPDATE

**Pilarcitos Integrated Watershed Management Plan
Watershed Assessment Update**

Philip Williams & Associates, Ltd.

September 29, 2008

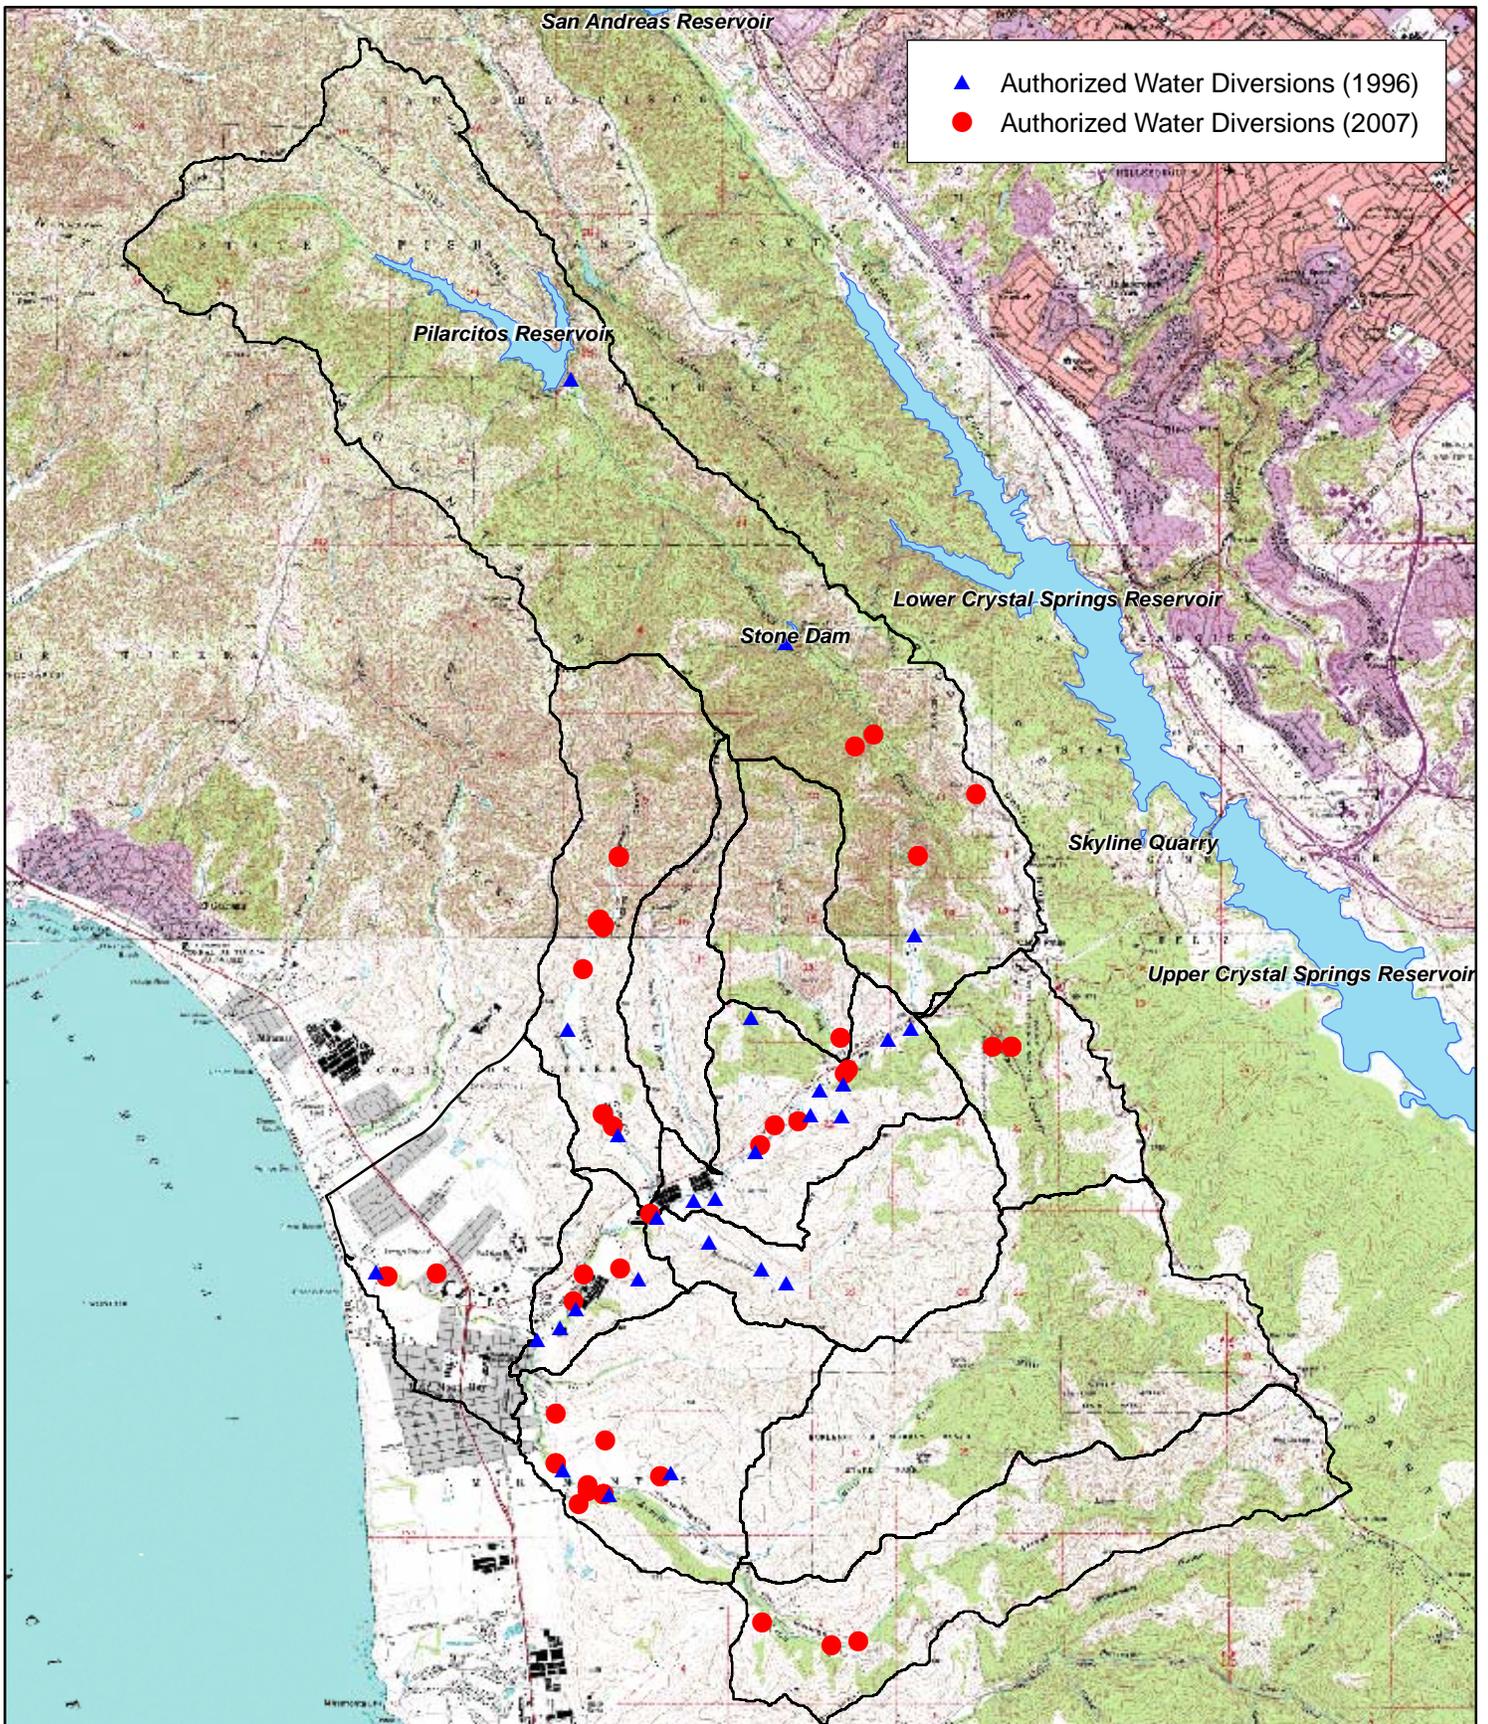
figure 22

Source: USGS (DRG), SFPUC (water bodies), 2007 Water Diversions were downloaded from the WRIMS State Water Resources Control Board database on June 21, 2007.

We updated the previous summary of permitted and unpermitted water rights diversions using SWRCB WRIMS database (<http://www.waterrights.ca.gov/> accessed on June 20, 2007). Figure 22 is a map of authorized diversions as registered at the WRIMS database from the Restoration Plan (PWA 1996) and from 2007. Table 7 summarizes permitted appropriative water rights diversions, as well as statements of pre-1914 diversions for each subwatershed. The amount of permitted appropriative diversions in the watershed total about 878 acre-feet per year. Most appropriative users are prohibited by conditions in their permit or licenses from diverting water during the summer. The amount of riparian diversion and pre-1914 appropriative diversions are reported in statements filed with the SWRCB as 2,296 acre-feet per year. The details of both permitted diversions and statements are provided in Table 7.

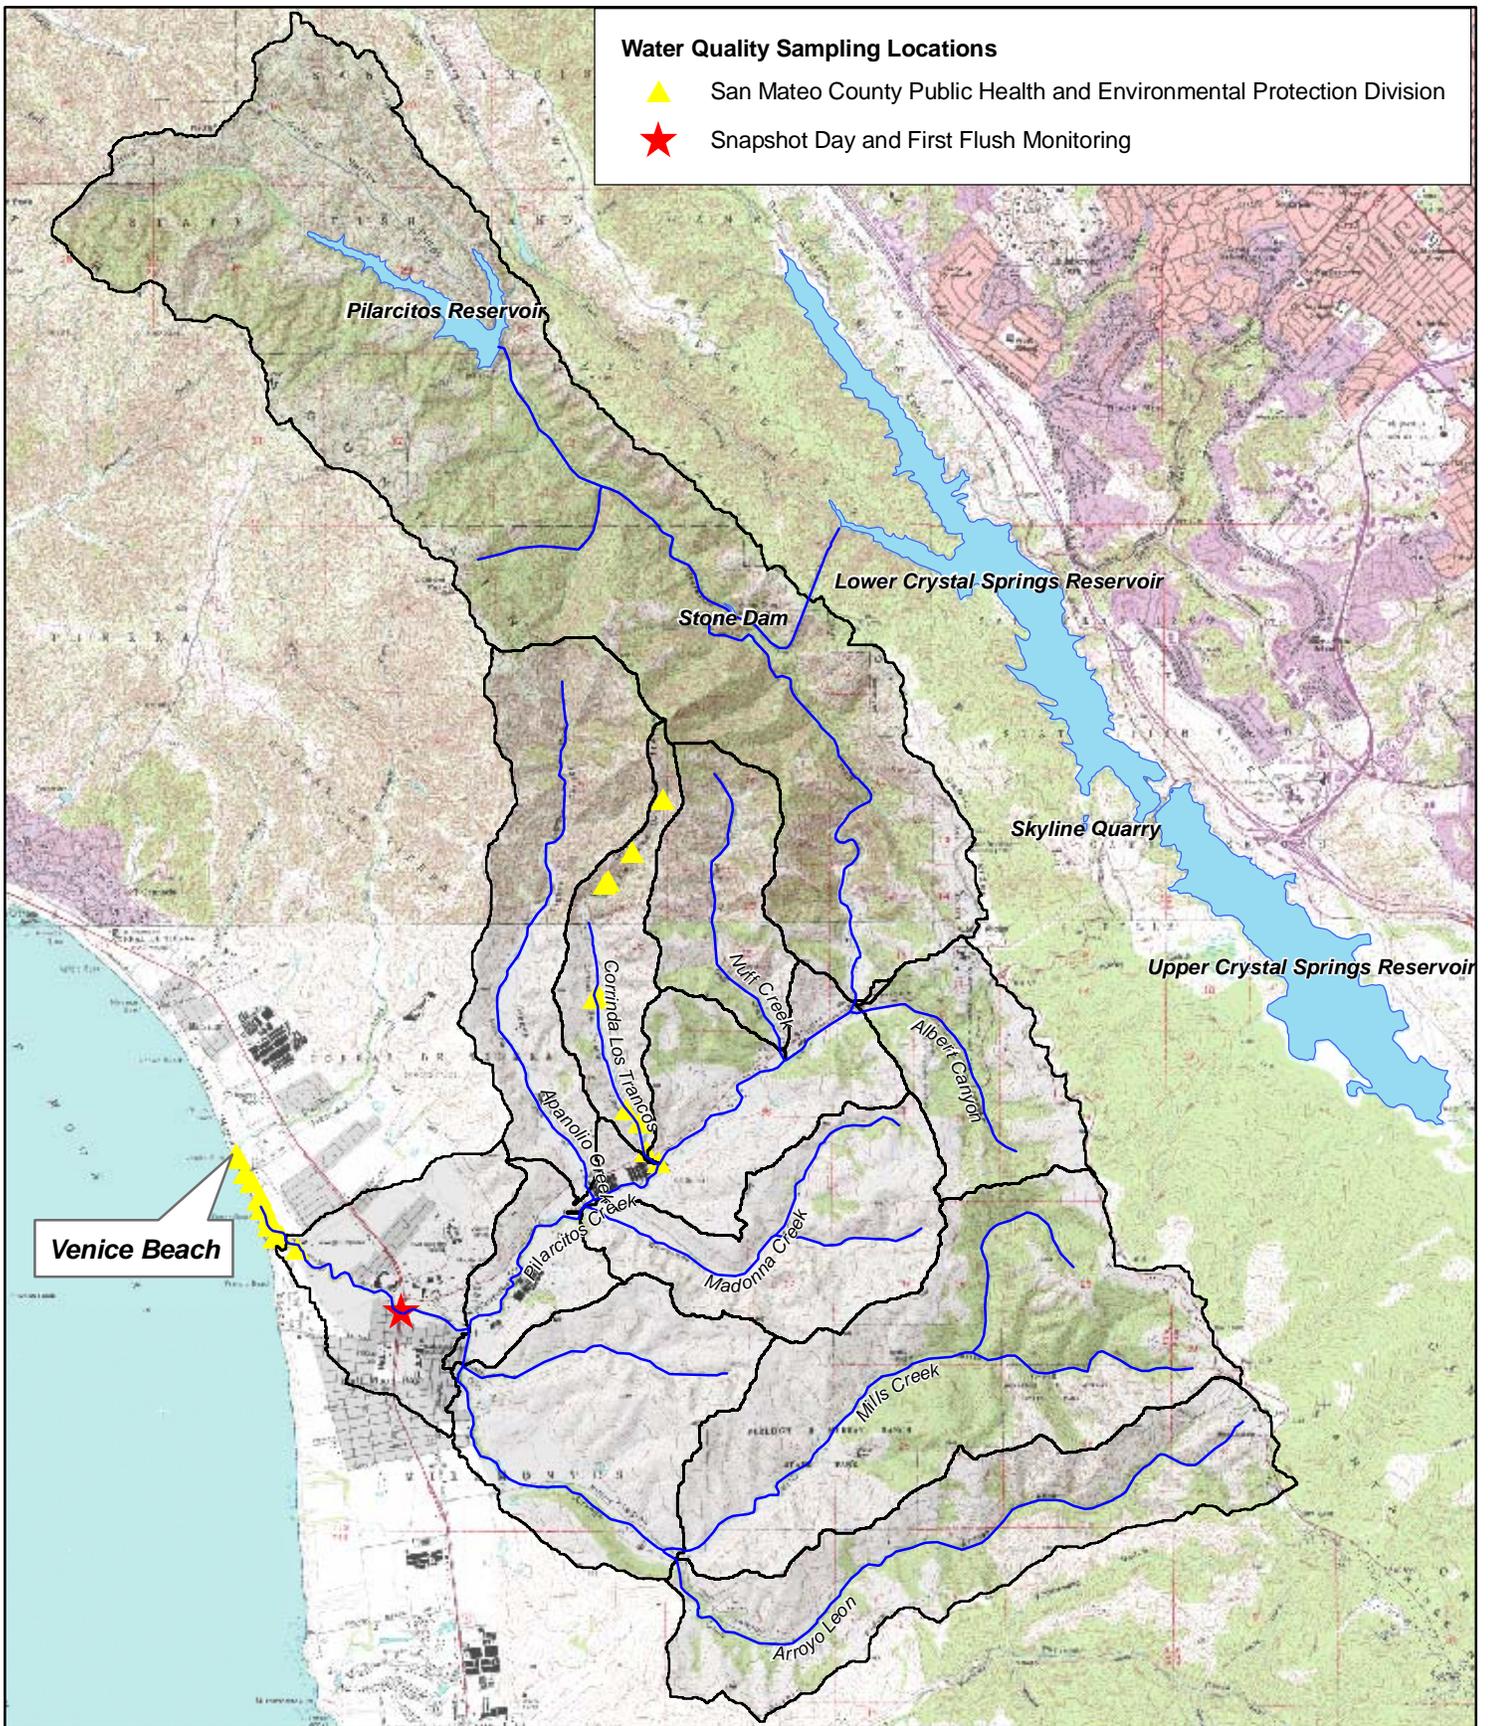
figure 23

Water Quality Sampling Locations

- ▲ San Mateo County Public Health and Environmental Protection Division
- ★ Snapshot Day and First Flush Monitoring

Extensive water quality monitoring in the Pilarcitos Creek watershed has resulted in large part from increasing concern about degraded conditions at Venice Beach, where Pilarcitos Creek enters Half Moon Bay (Figure 23). PWA reviewed a number of different sources related to water quality in Pilarcitos Creek.

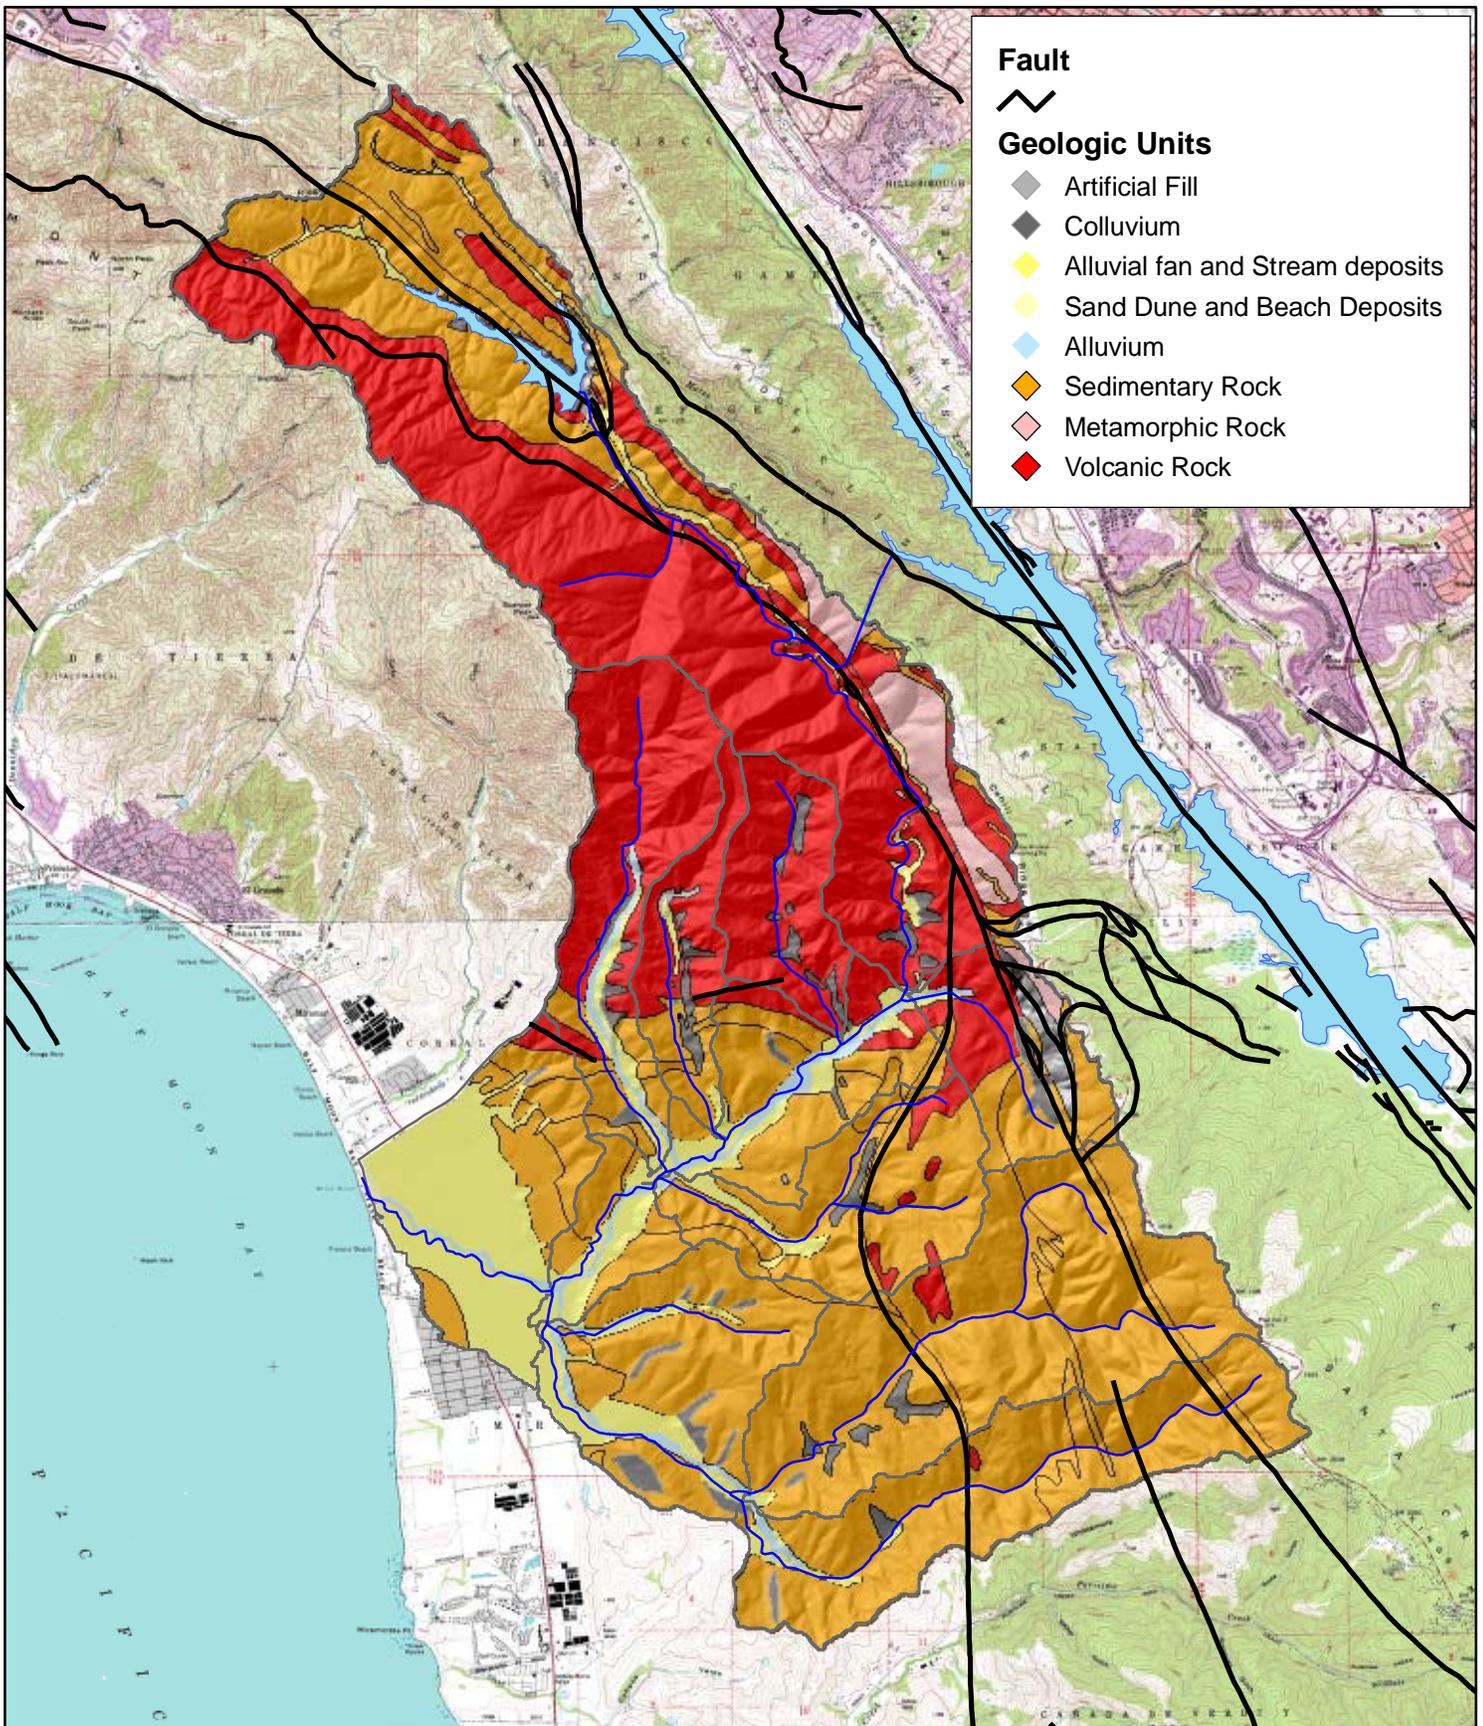
figure 24

Source: USGS (DRG, DEM, Geology), SFPUC (water bodies)

Geology in the Pilarcitos watershed is primarily a mixture of sedimentary and volcanic rocks (Figure 24) (Brabb et al. 1998). Sedimentary rocks of the Franciscan assemblage and the Monterey Formation are found throughout the eastern part of the watershed in the Madonna, Mills, and Arroyo Leon subwatersheds and are found to a lesser degree in the Apanolio and Corinda Los Trancos subwatersheds. Limestone and greywacke exist in Upper Pilarcitos above Pilarcitos Reservoir. Volcanic rocks, predominantly granitic rocks of Montara Mountain (Brabb et al. 1998), are found throughout the western part of the watershed in the Upper Pilarcitos, Apanolio, Corinda Los Trancos, and Nuff Creek subwatersheds.

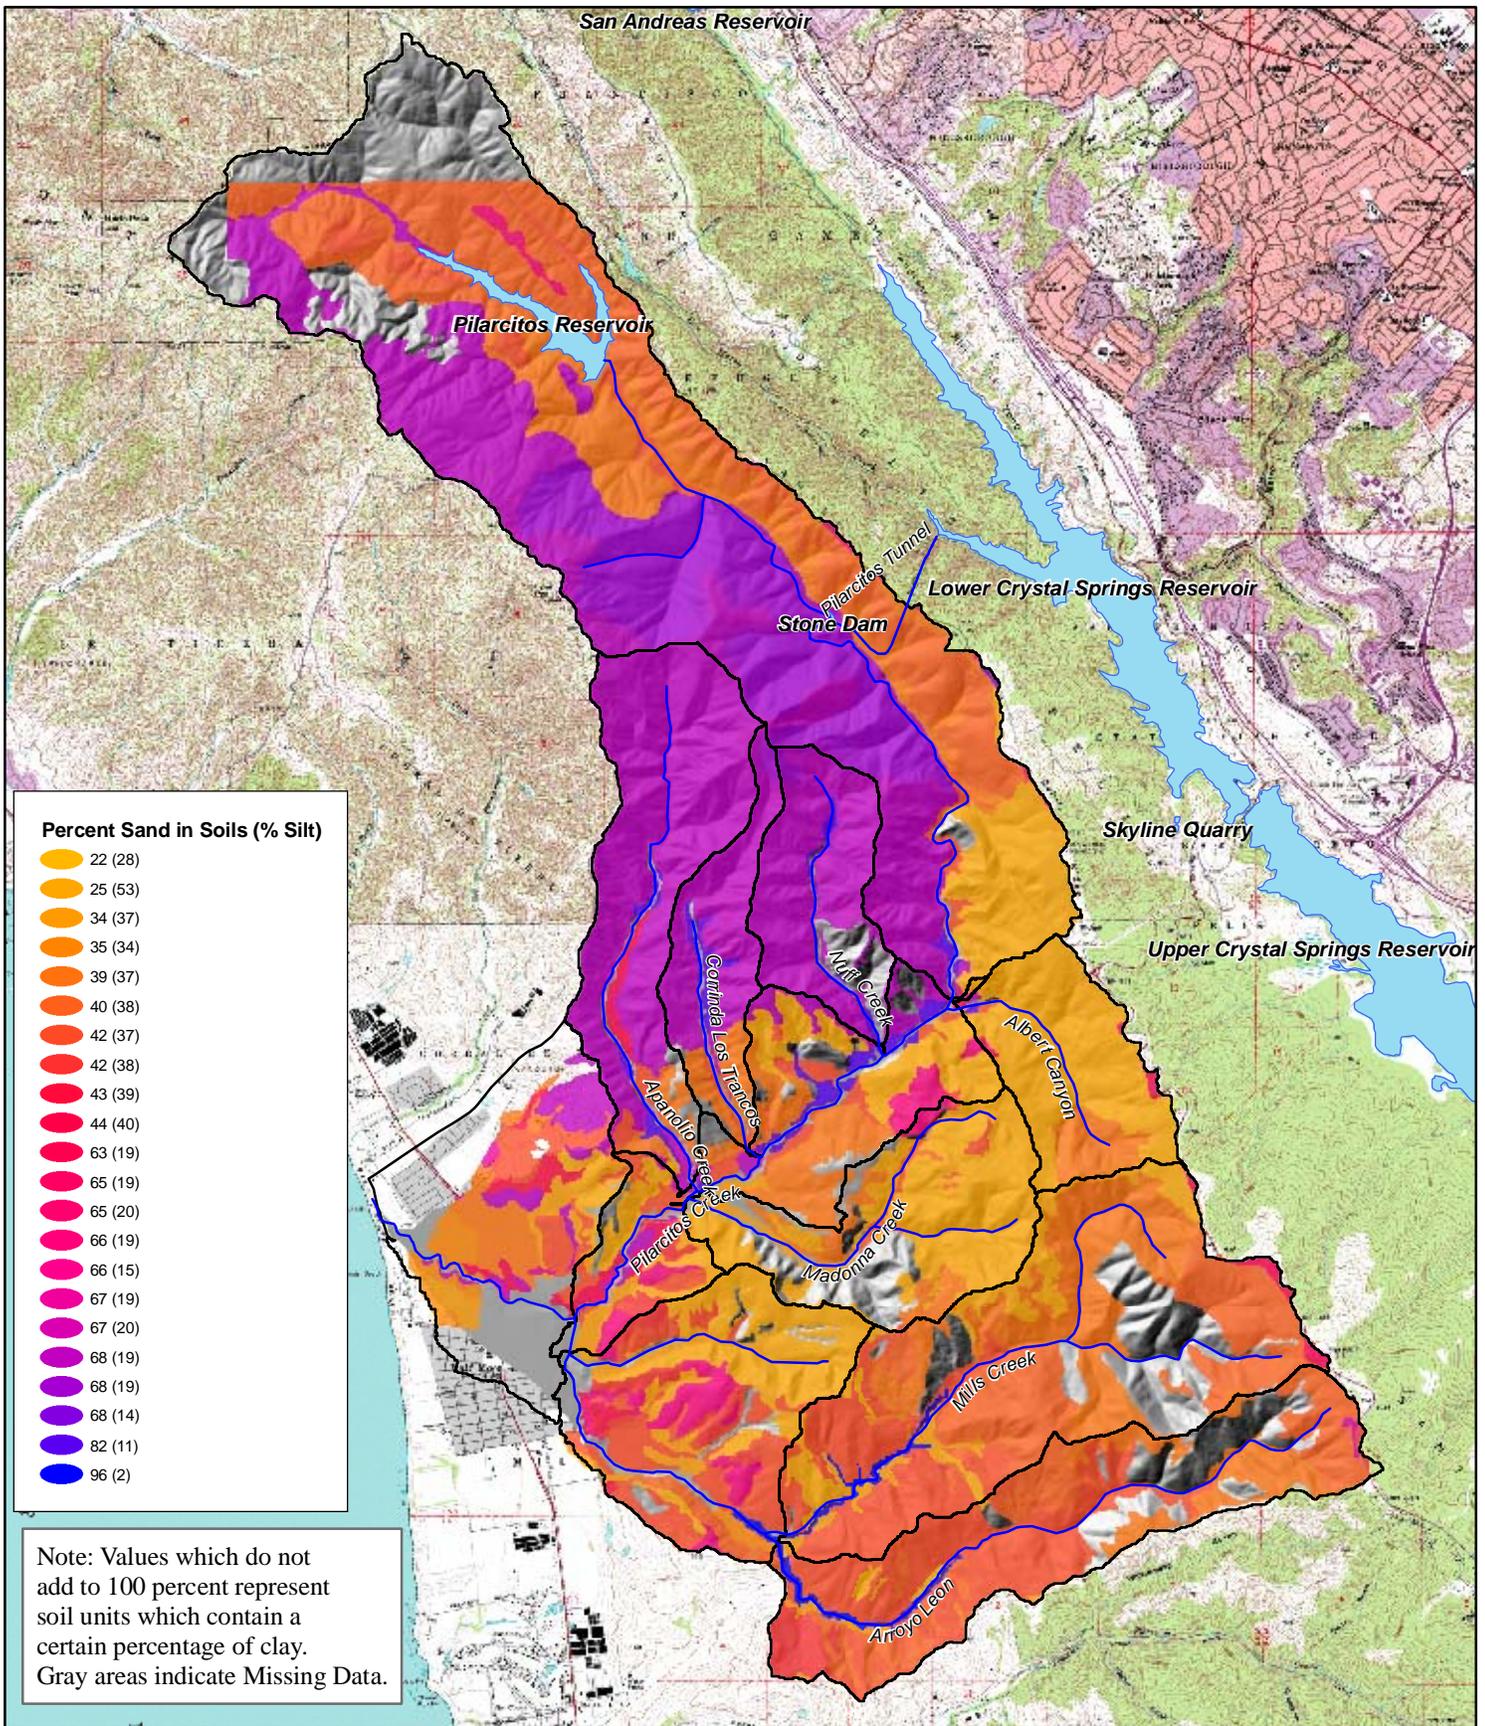
figure 25

- Figure 23. Water Quality Sampling Locations Water Quality Sampling Locations
- Figure 24. Geologic Units and Surface Deposits
- Figure 25. Soil Particle Size

Source: USGS (DRG, DEM), SFPUC (water bodies), NRCS (soils)

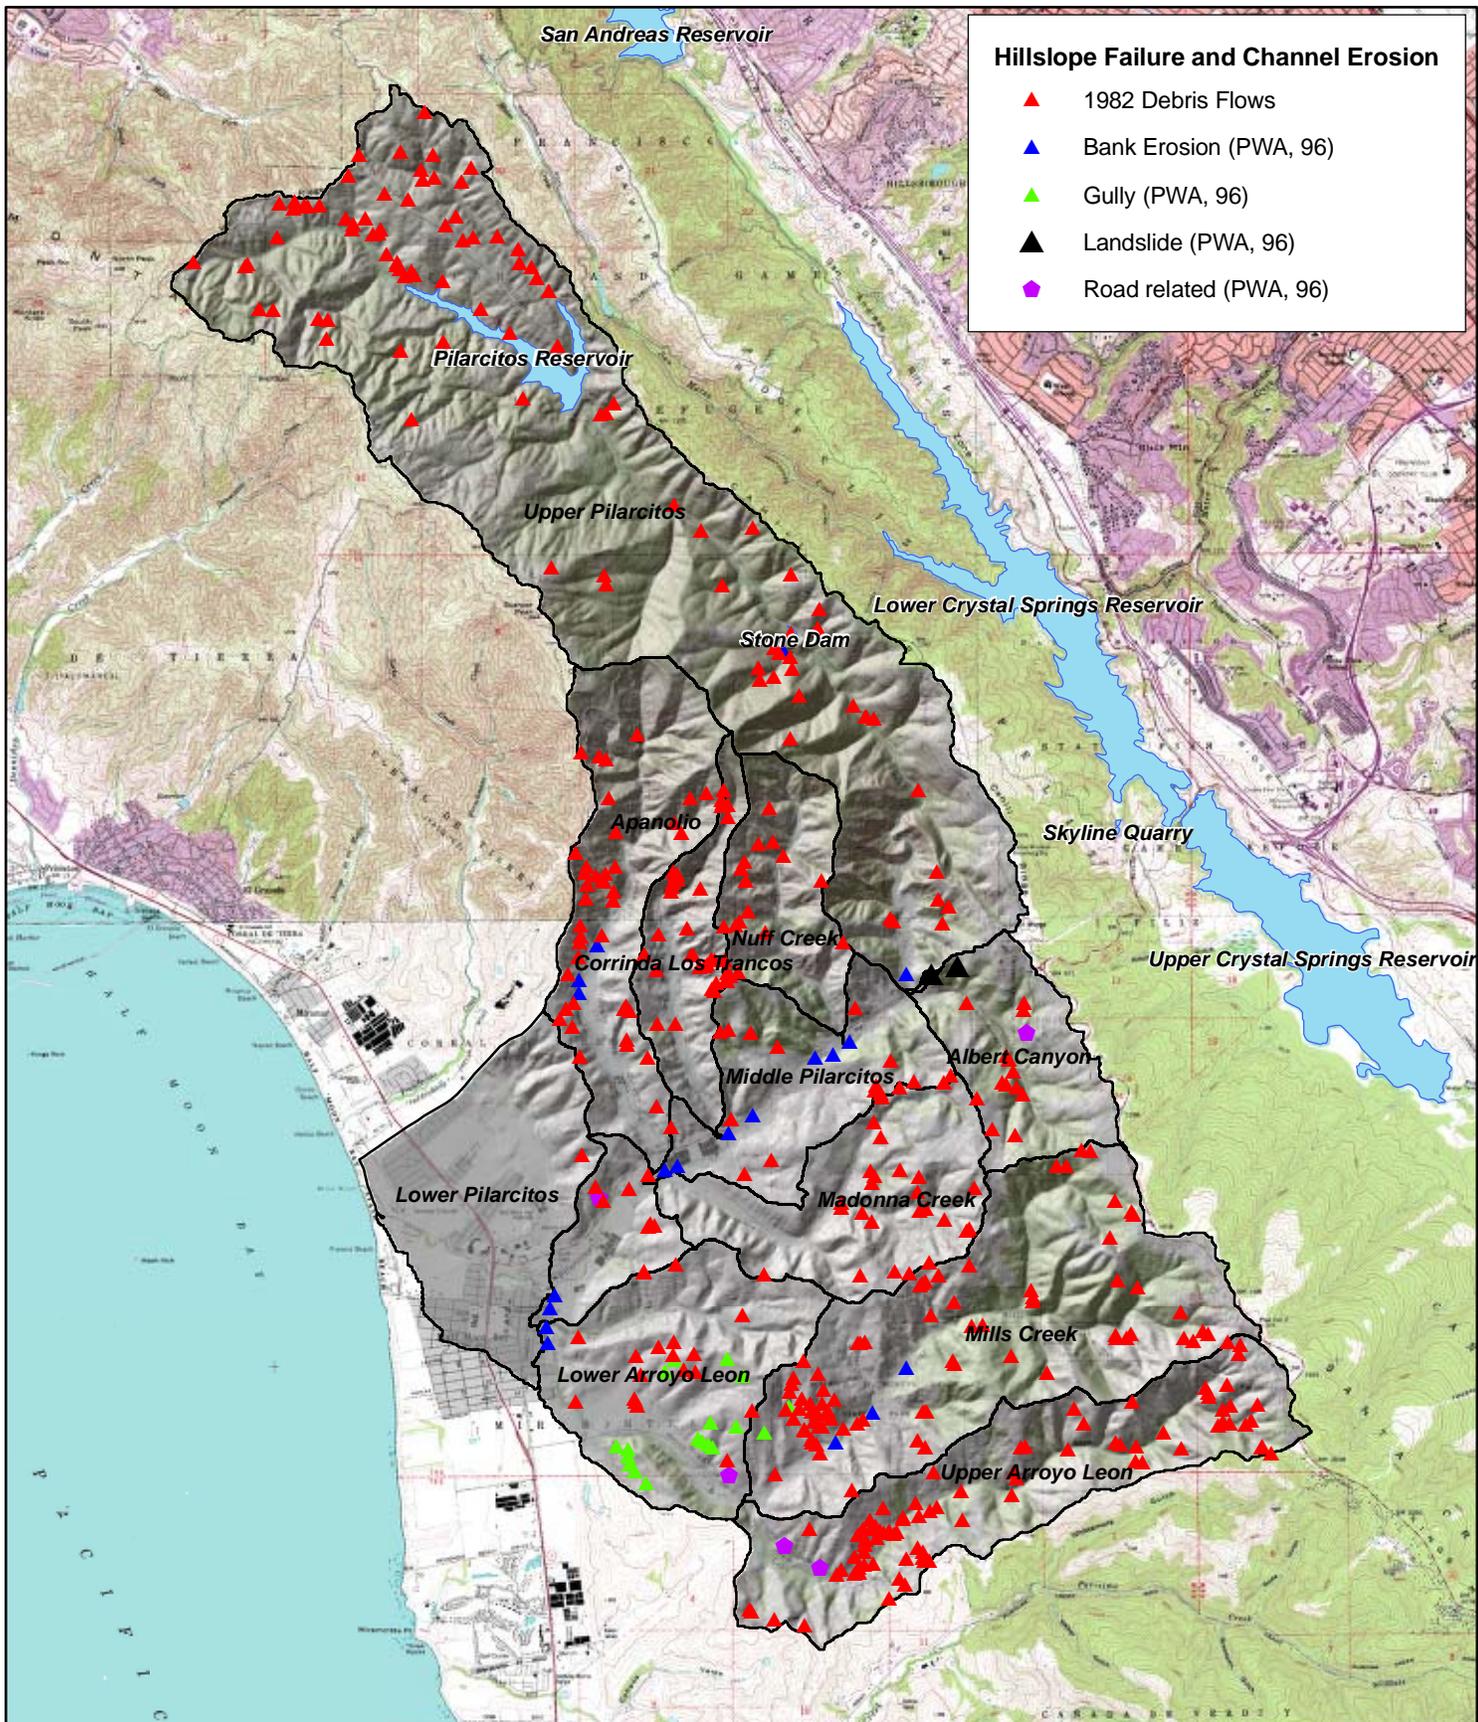
figure 26

Source: USGS (DRG, Debris Flows), SFPUC (water bodies), PWA (Bank Erosion, Road Related Erosion, Landslides, Gullies)

Pilarcitos IWMP
Hillslope Failure and Channel Erosion

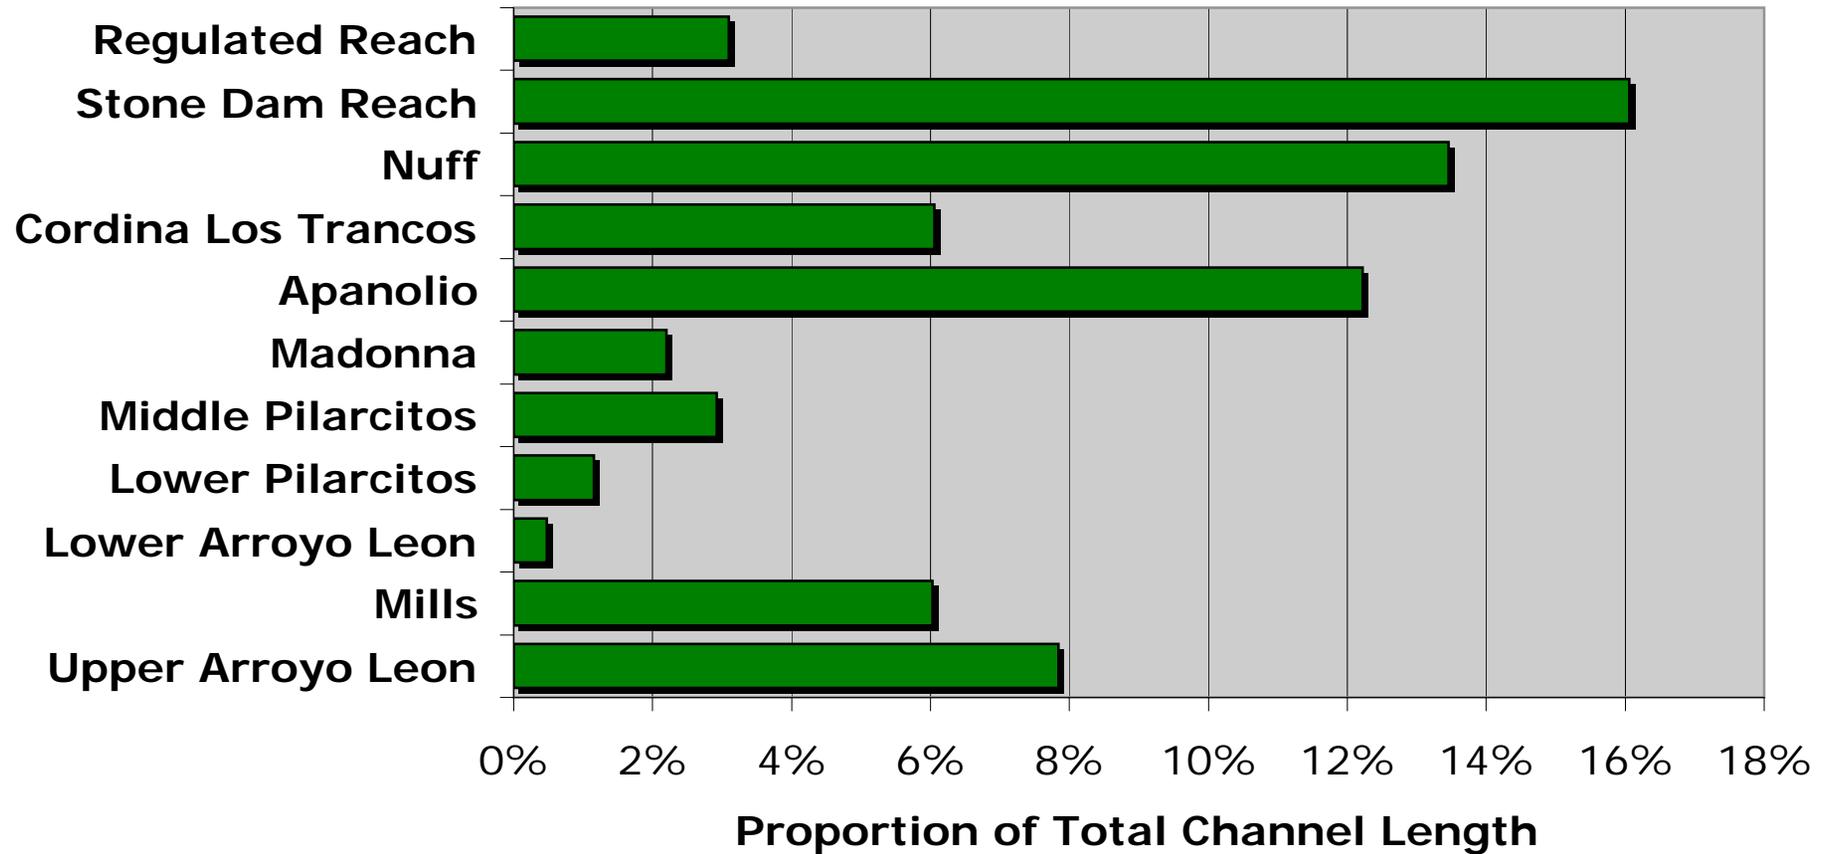
figure 27
Pilarcitos IWMP

Channel Length Greater Than 60% Slope

The extent to which natural hillslope erosion (gullies, landslides, debris flows) contributes to channel sedimentation is defined by the source-area gradient or slope, convergence, deposition-site conditions, and connectivity with the Pilarcitos Creek mainstem and/or the tributary channels (Benda and Cundy 1990). This connection between the hillslope and the channel is influenced heavily by the steepness of the slopes in the watershed. Steeper, convergent slopes also tend to be more erosive as they are more prone to failure in the form of landslides and debris flows (Deitrich and Dunne 1978). Upon failure, such features create a “hollow” that cyclically fills and evacuates over a period of decades to millennia (Dietrich et al 1987). The proportion of each watershed that contains these sources of landslide and debris flow sediment was evaluated by integrating a two different DEM analysis tools (convergent channel network and slope) and performing basic statistics for the distribution of these features. The convergence channel network was defined for all linear features with a contributing area greater than five acres, and equals over 416 miles for the entire watershed, 61 percent of which includes hollows (Table 8). The steep convergent channels are predominant in the reach below Stone Dam, Nuff Creek and Apanolio Creek (Figure 27).

Balance (2003a) suggested that this result was counter-intuitive because of the sedimentary rocks found in the Arroyo Leon and Mills Creek, which they described as more erodible than the granitic rocks of Montara Mountain. However, both Balance (2003b) and Brabb et al. (1998) note the highly fractured and deeply weathered nature of the granitic rocks found in the Apanolio, Corinda Los Trancos, and Nuff Creek subwatersheds and in the lower portion of Upper Pilarcitos below Stone Dam (Figure 24). These subwatersheds also contain a high average hillslope gradient and a larger area with slopes greater than 60 percent (Figure 27 and Figure 28).

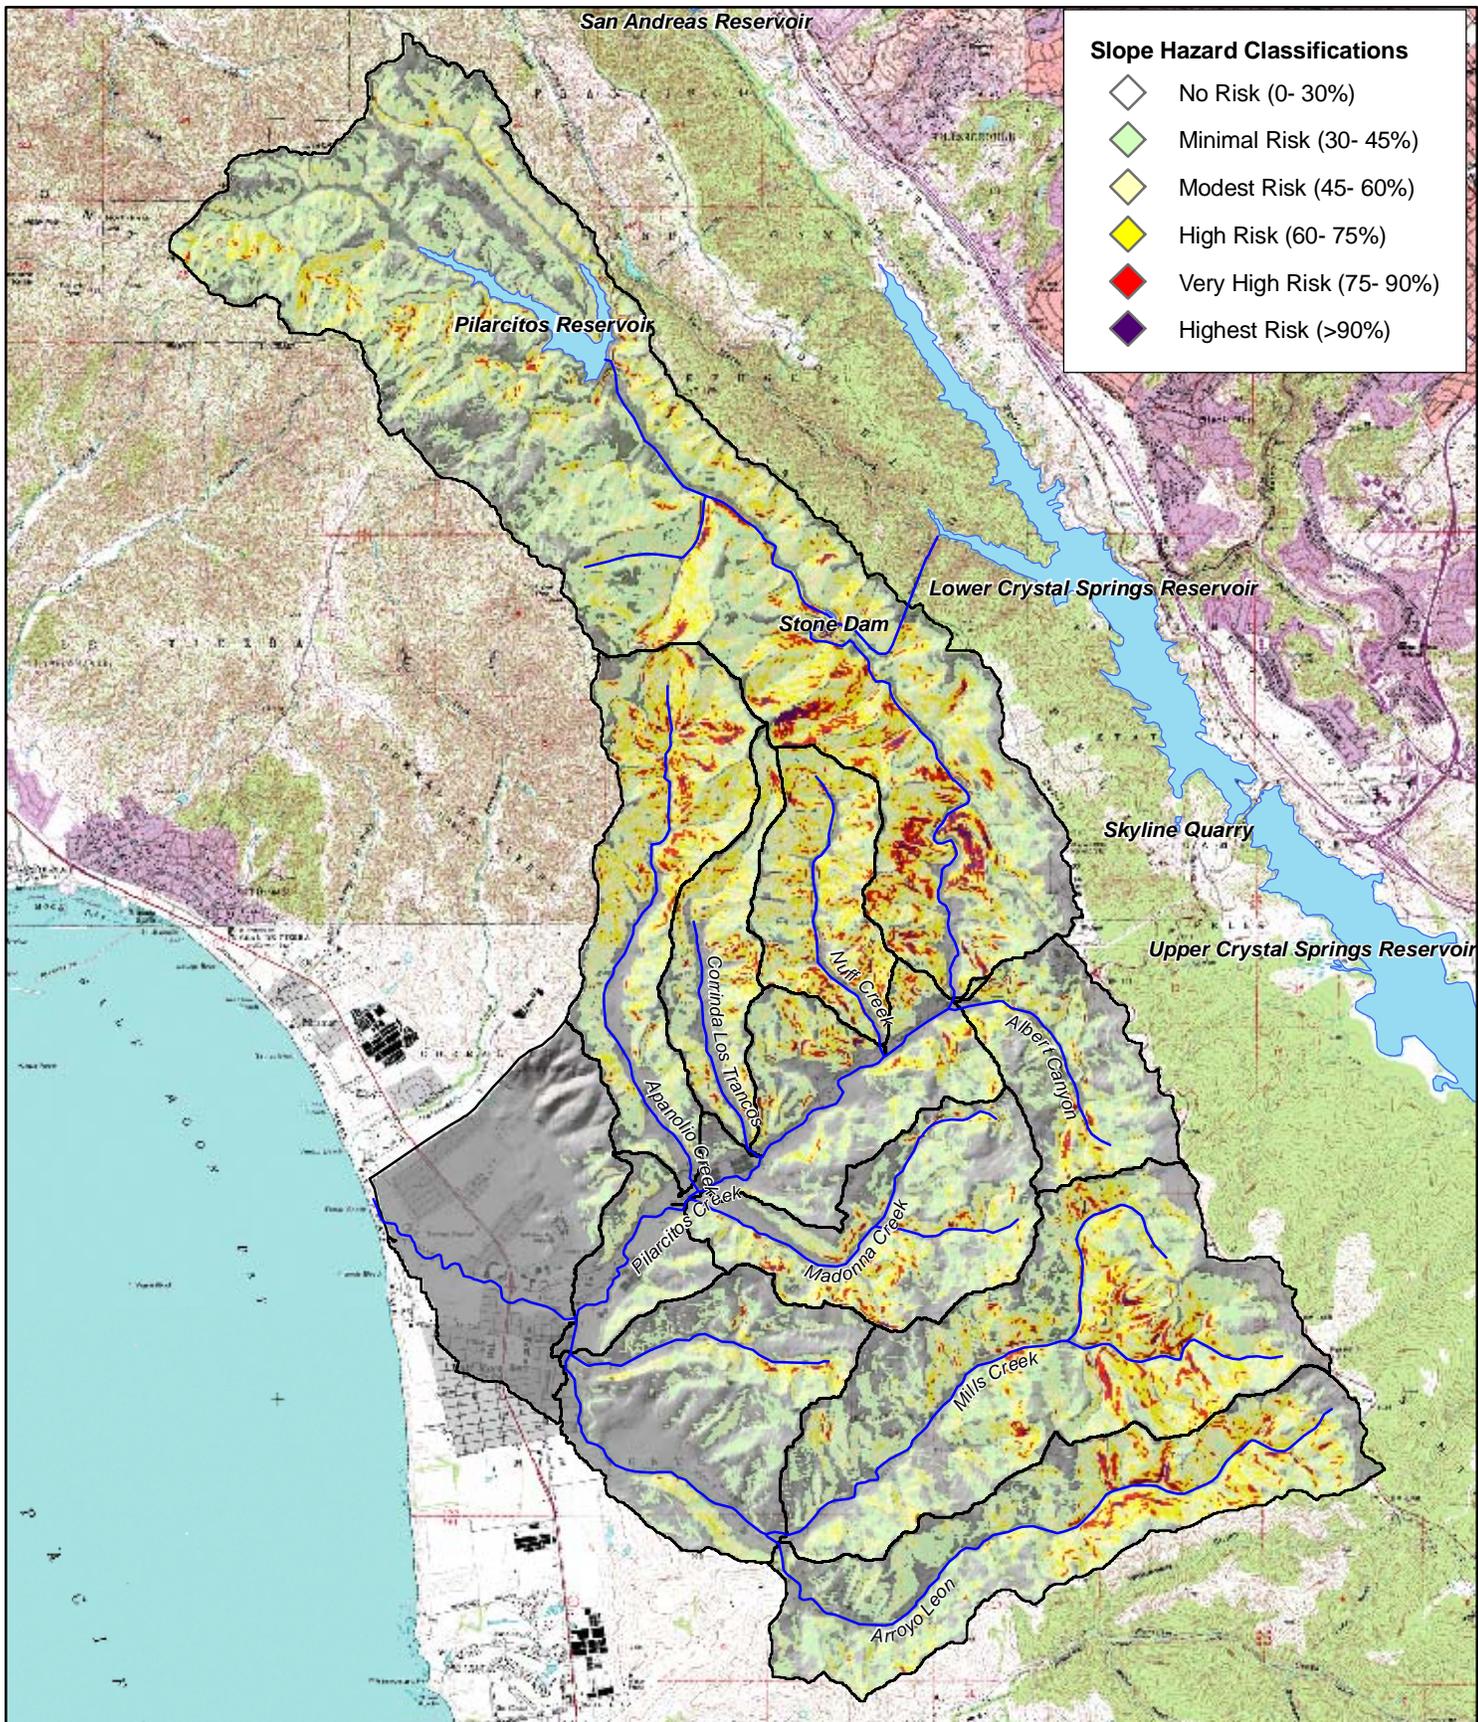
figure 28

Source: USGS (quadrangle, dem), SFPUC (water bodies)
 SWC (Slope classifications)

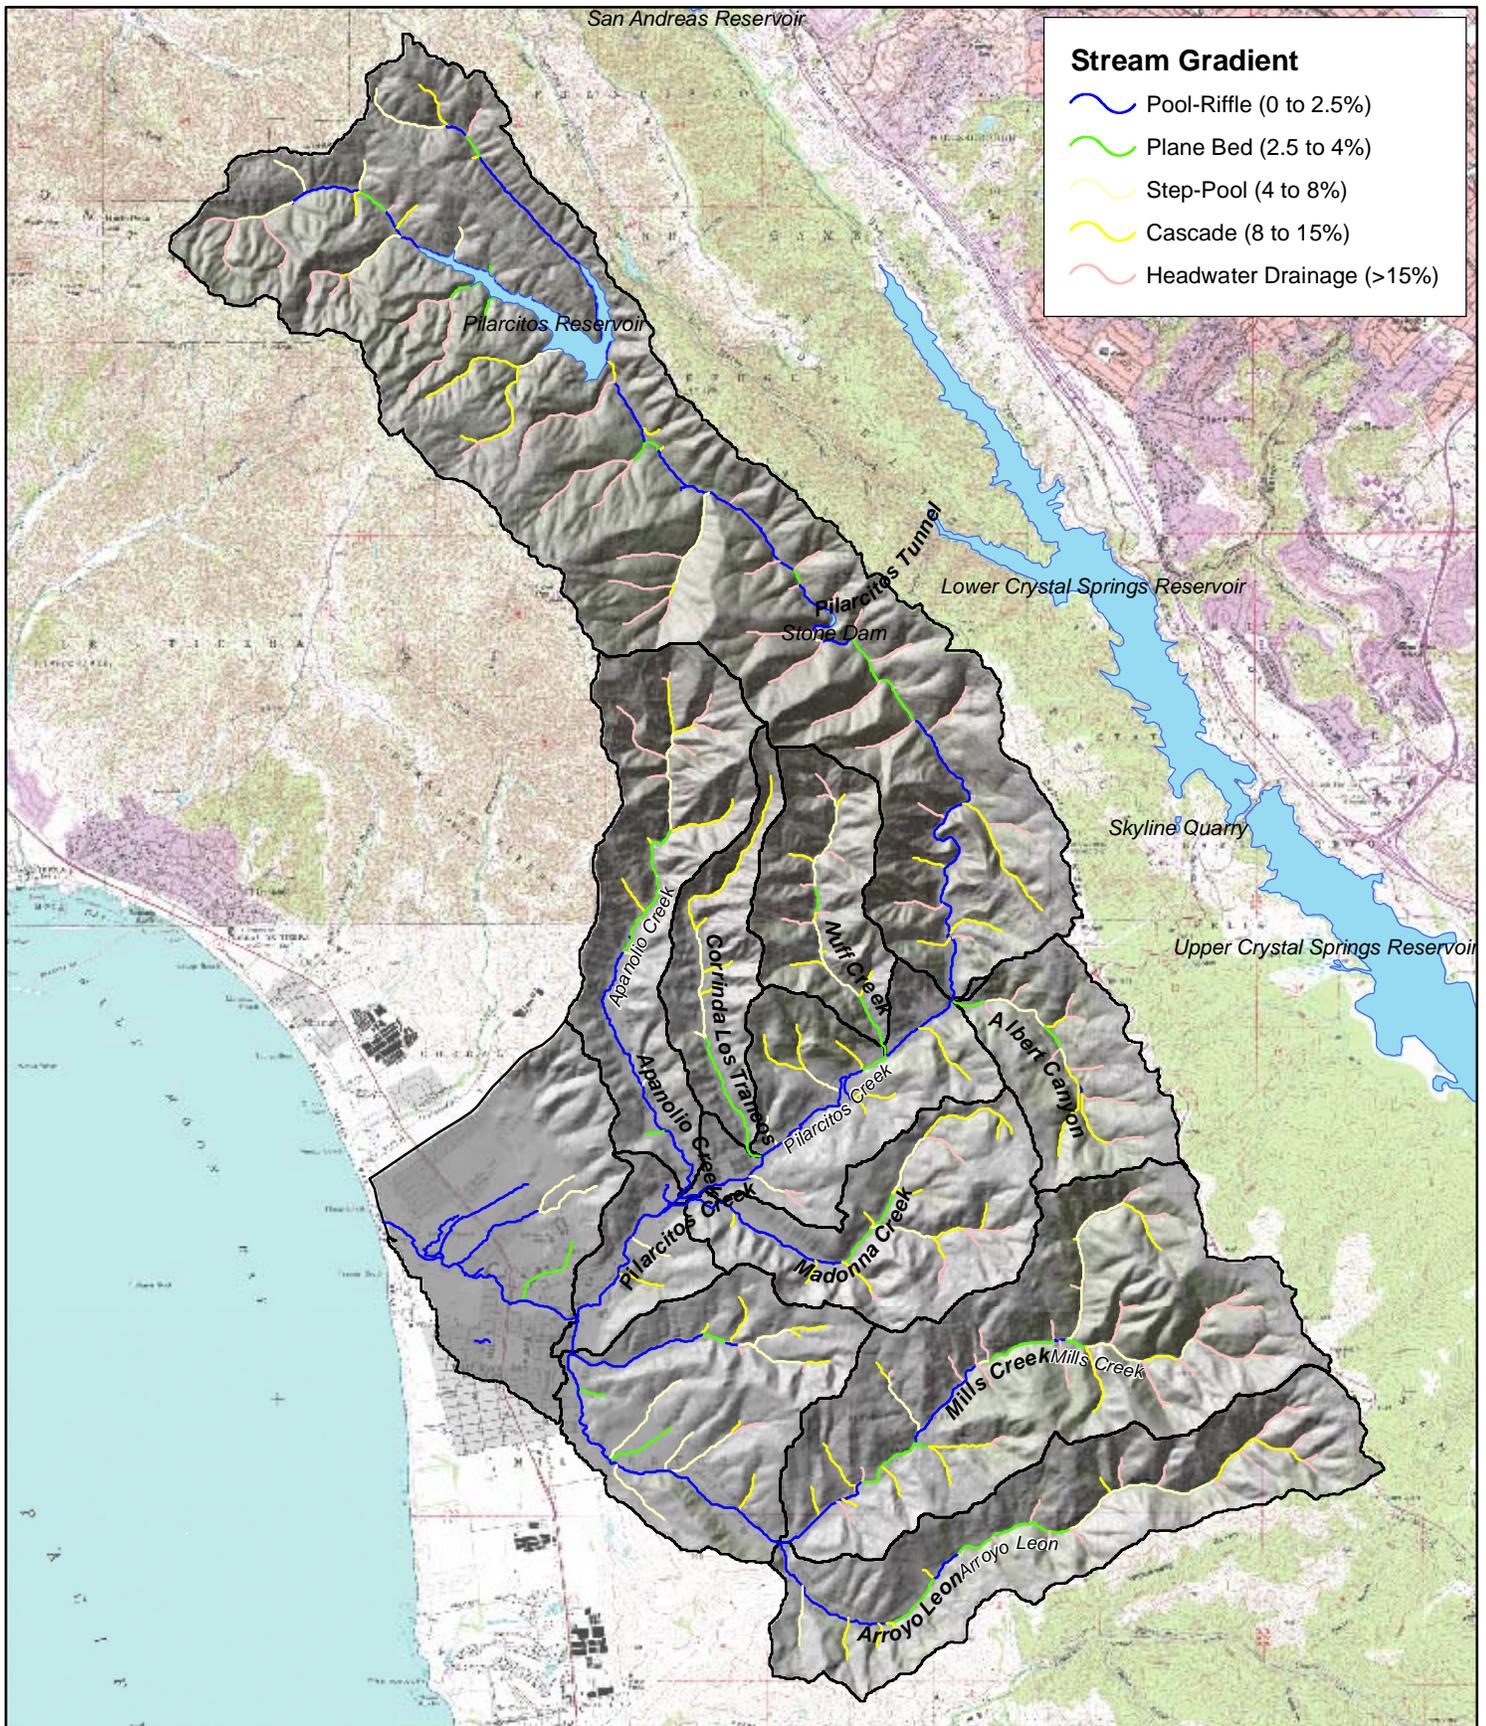
figure 30

- Figure 26. Hillslope Failure and Channel Erosion
- Figure 27. Channel Grade Summary
- Figure 28. Watershed Slope
- Figure 29. Partial Road Map
- Figure 30. Stream Gradient in the Pilarcitos Watershed

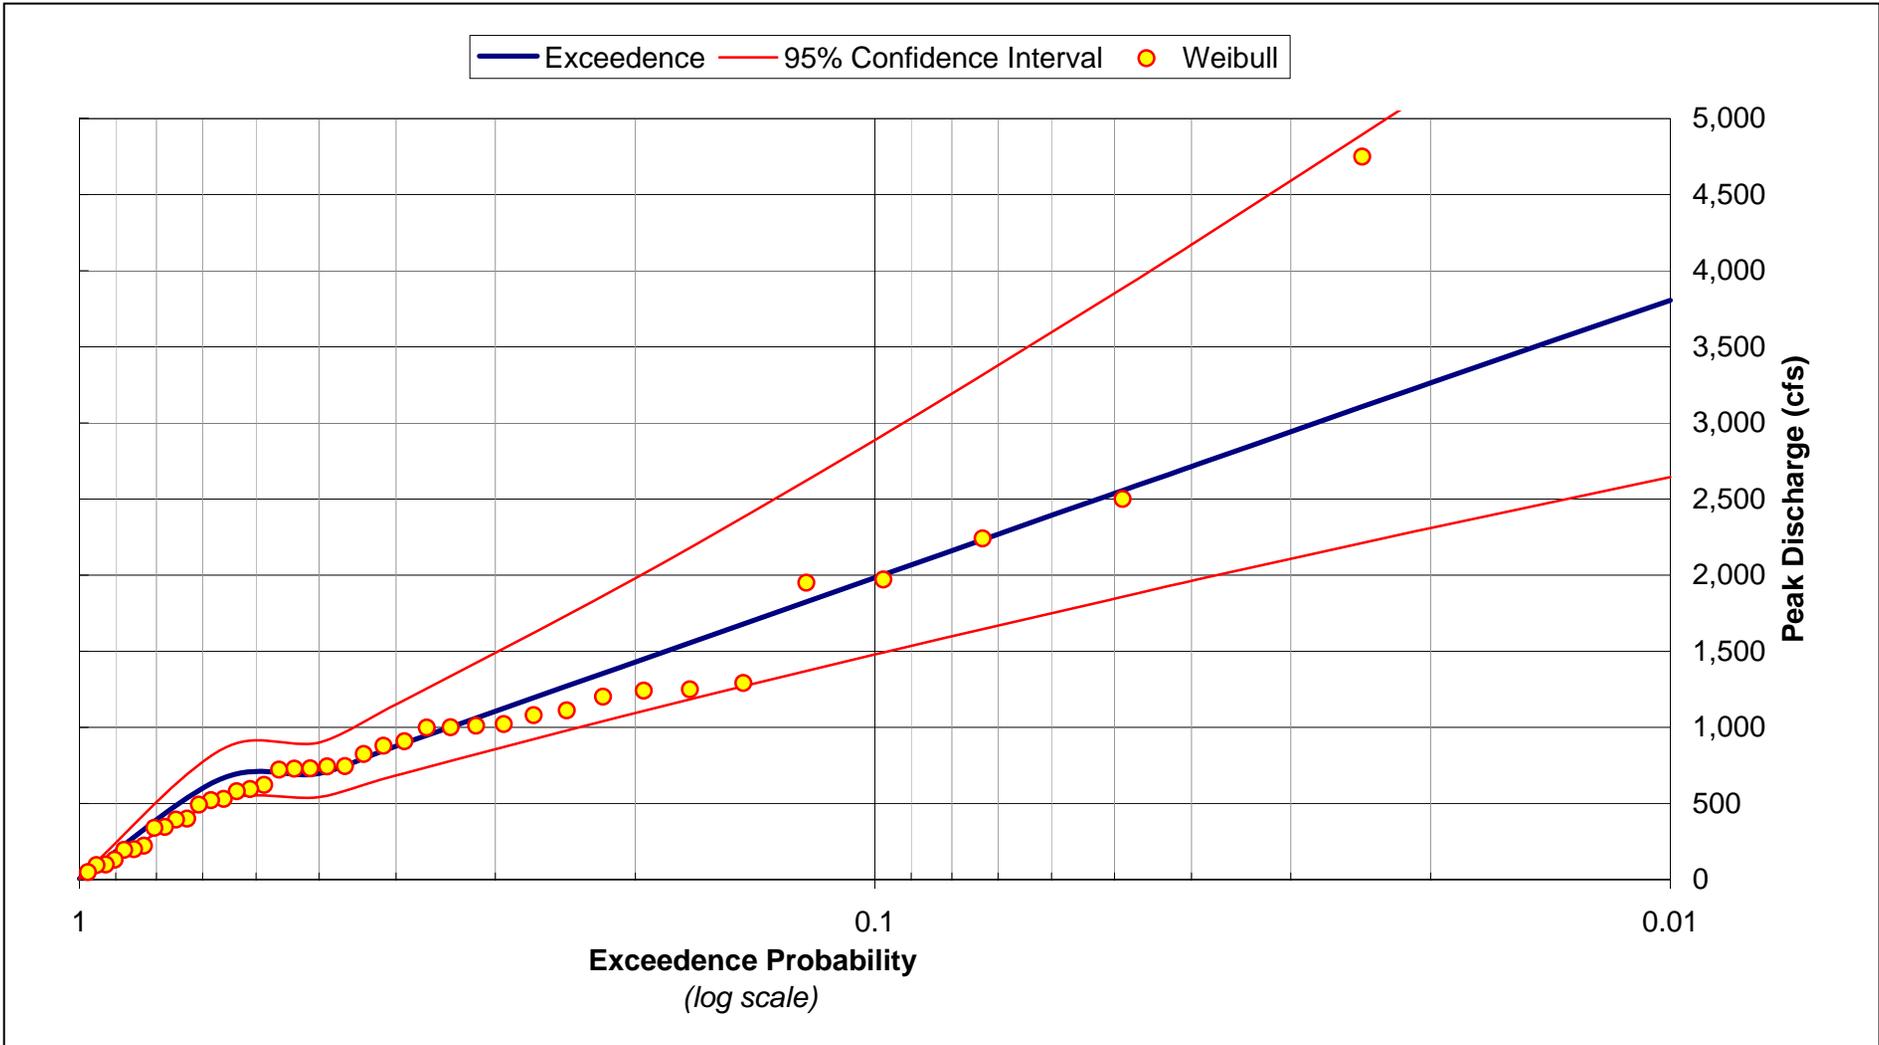
figure 31
 Pilarcitos IWMP

- Figure 31. Annual Peak Discharge Probability Pilarcitos Creek at HMB
- Figure 32. California Wildlife Habitat Relationship (CWHR) Vegetation Data
- Figure 33. Locations of Riparian Plant Communities and Eucalyptus Groves (South)

Notes: USGS Station xxx (Pilarcitos Creek at Half Moon Bay)
 Source: Sound Watershed Consulting
