Appendix A
PILARCITOS INTEGRATED WATERSHED MANAGEMENT PLAN
WATERSHED ASSESSMENT UPDATE

**Pilarcitos Integrated Watershed Management Plan
Watershed Assessment Update**

Philip Williams & Associates, Ltd.

September 29, 2008

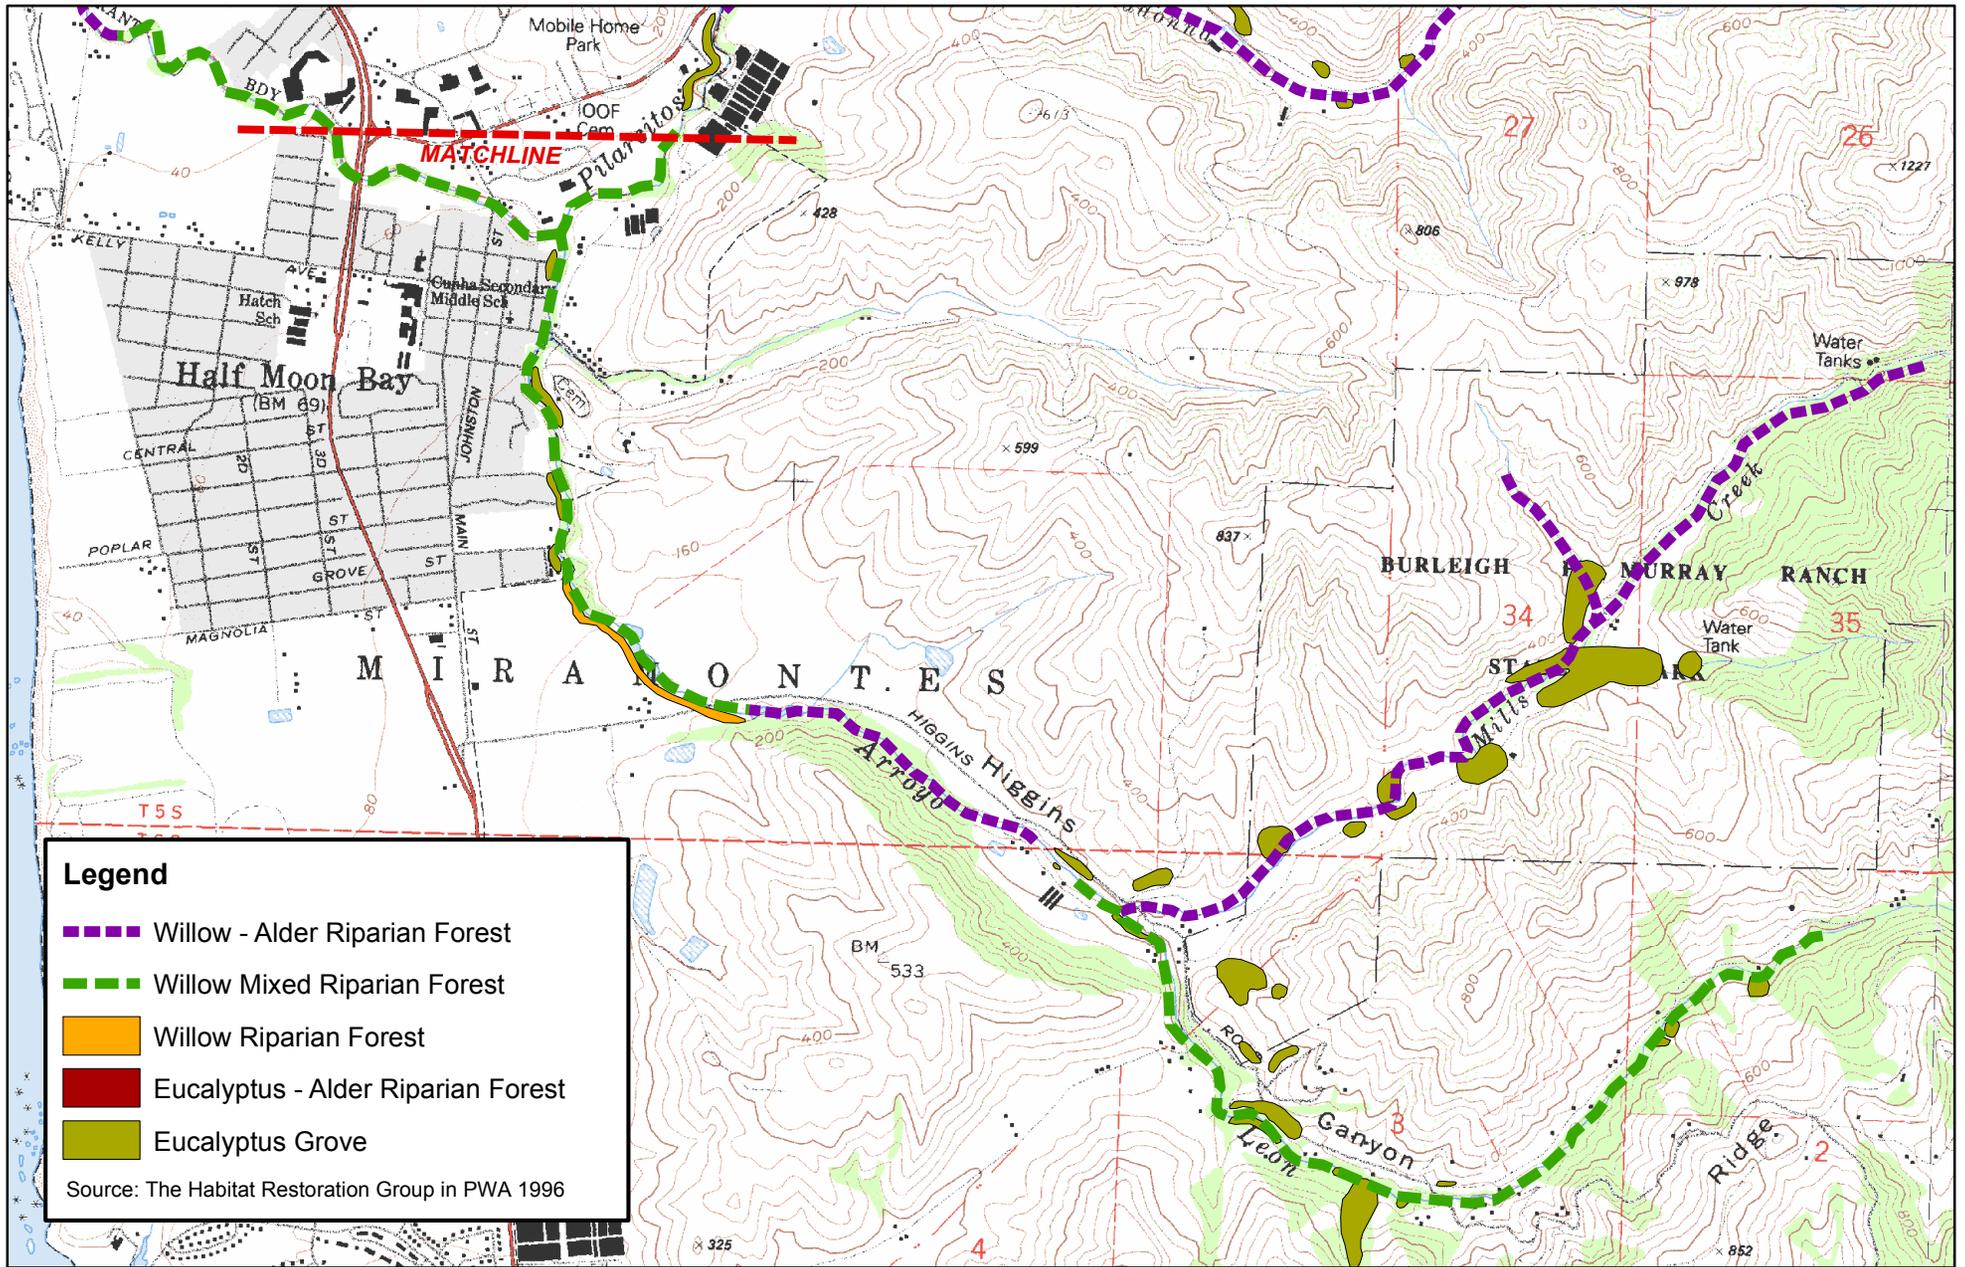
- - - Willow - Alder Riparian Forest
- - - Willow Mixed Riparian Forest
- Willow Riparian Forest
- Eucalyptus - Alder Riparian Forest
- Eucalyptus Grove

Red alder (*Alnus rubra*), arroyo willow (*Salix lasiolepis*), and yellow willow (*Salix lutea*) dominate the upper canopy of Willow-Alder Riparian Forest. Examples of this type of riparian forest occur along the lower reaches of Apanolio Creek, Madonna Creek, upper Arroyo Leon, and Mills Creek (Figure 33 and Figure 34). In addition to the dominant tree species, California buckeye (*Aesculus californicus*), blue gum eucalyptus (*Eucalyptus globulus*), Monterey cypress (*Cupressus macrocarpa*), and Douglas fir occur in scattered locations. The shrub layer is dominated by California blackberry, poison oak, and coast elderberry. Additional shrub species that are present include coffeeberry (*Rhamnus californica*), snowberry (*Symphoricarpos albus var. laevigatus*), thimbleberry (*Rubus parviflorus*), and creek dogwood (*Cornus sericea*). Dominant plant species in the herbaceous understory include stinging nettle (*Urtica dioica*), sword fern (*Polystichum munitum*), and hedge nettle (*Stachys bullata*). Non-native invasive species such as Cape ivy and poison hemlock are also prevalent in the herbaceous understory.

In riparian areas where eucalyptus has invaded and is out-competing native riparian tree species, the corridor was previously classified as either Eucalyptus-Alder Riparian Forest, or simply as a Eucalyptus grove (PWA 1996). Examples of this forest type occur along portions of the lower reaches of all seven creeks in the watershed (Figure 33 and Figure 34). Examples of extensively invaded corridors are evident at the junction of Nuff Creek, Pilarcitos Creek, and along sections of Mills Creek. Although this riparian forest type presently represents a unique forest composition and structure that provides certain wildlife habitat functions, it may be better to consider it as an invaded type of the previous three historic riparian habitat types (i.e. Willow Riparian, Willow-Alder Riparian, or Willow-Mixed Riparian Forest). According to this approach, Eucalyptus-Alder Riparian Forest would represent an example along the continuum from Willow Riparian Forest to pure Eucalyptus Grove. Considering the riparian habitat this way may be helpful in assessing the restoration potential of a given patch of riparian forest, whereby the least invaded areas may be the most cost-effective to restore to a willow or willow-alder type of riparian forest.

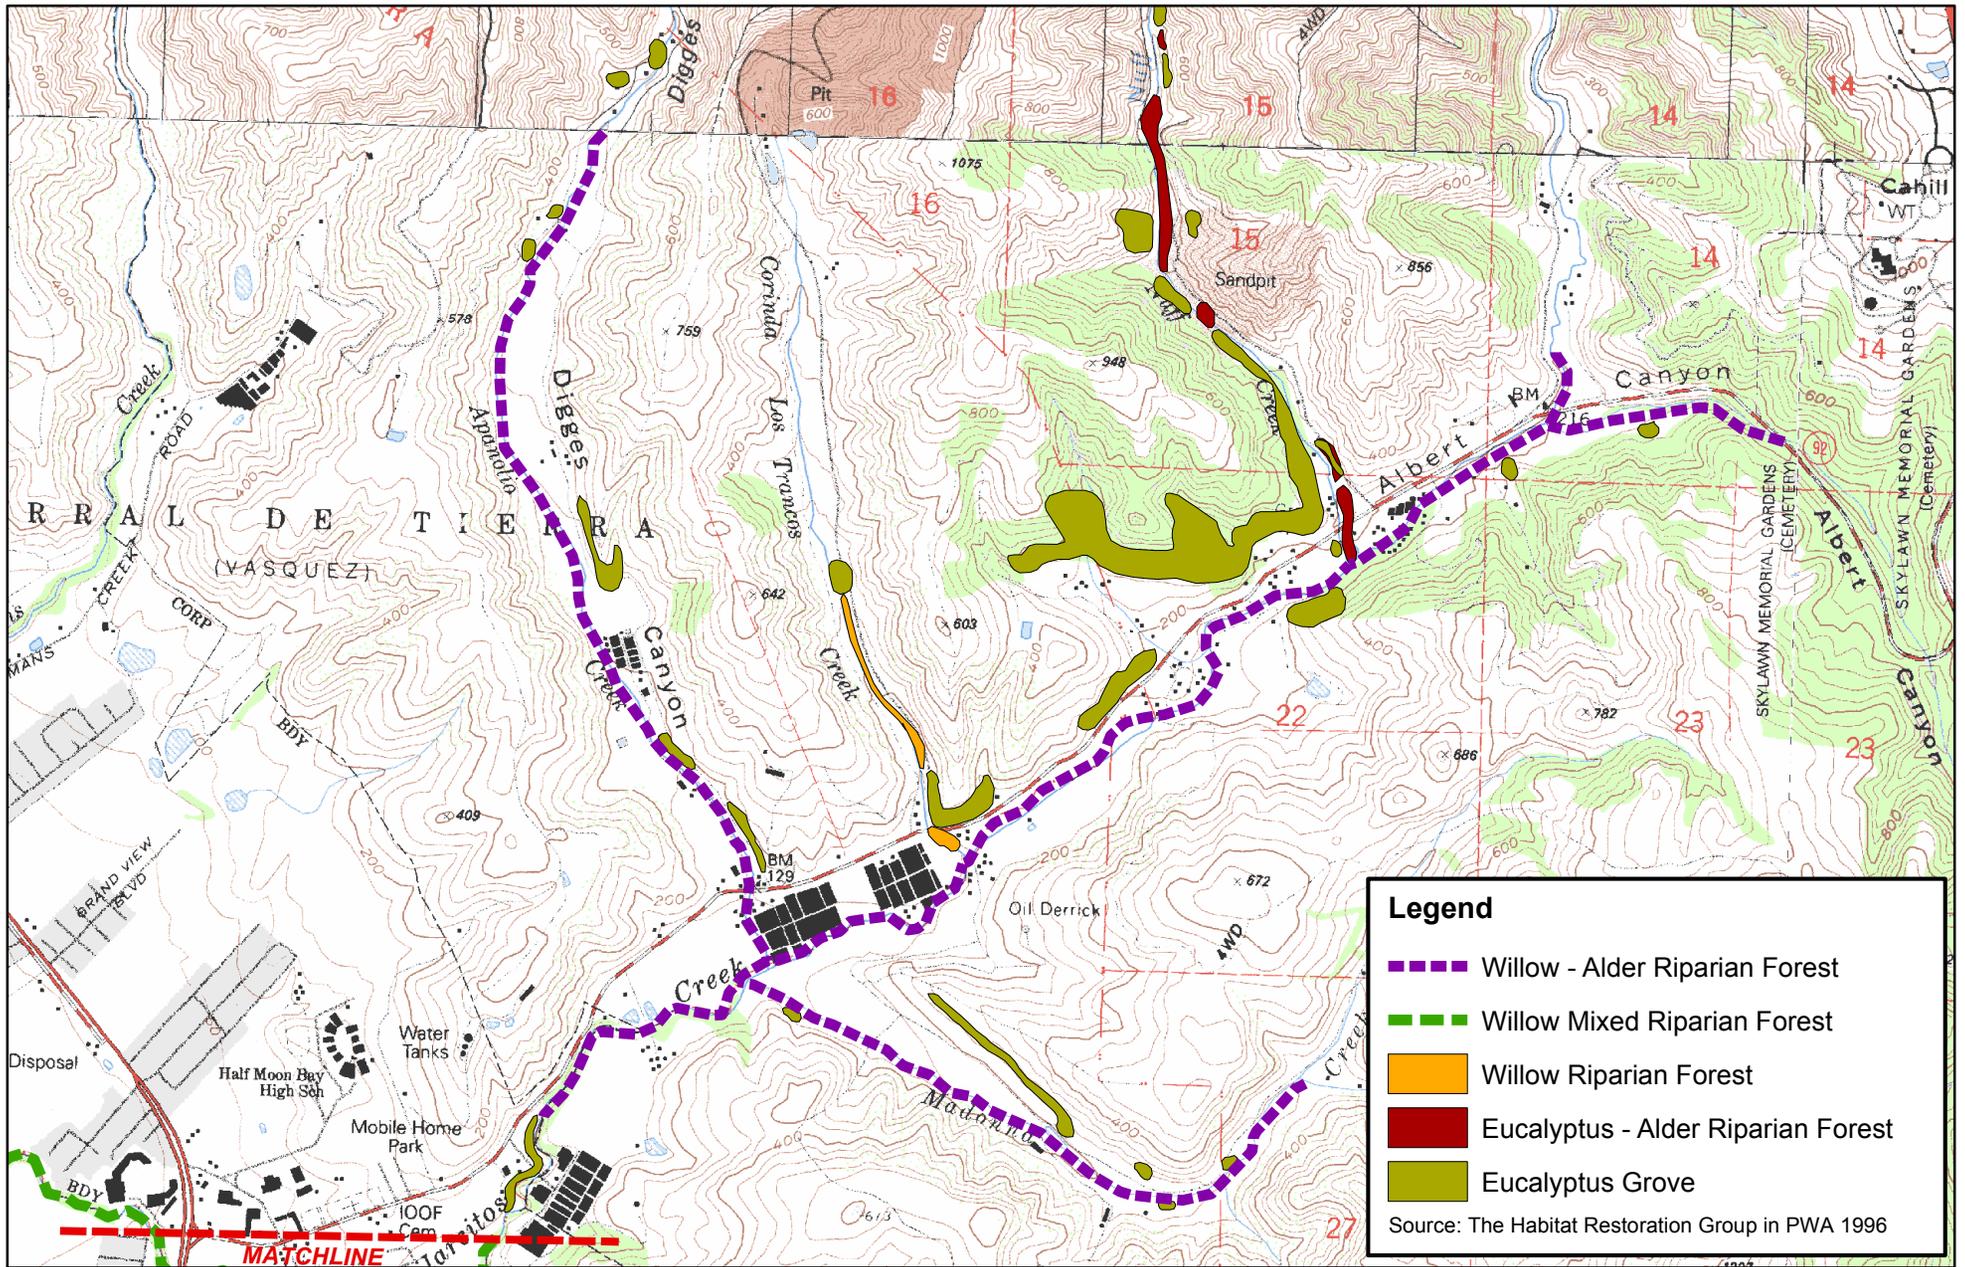
figure 34

- Figure 34. Locations of Riparian Plant Communities and Eucalyptus Groves (North)
- Figure 35. Locations of Significant Concentrations of Invasive, Non-native Plant Species (South)

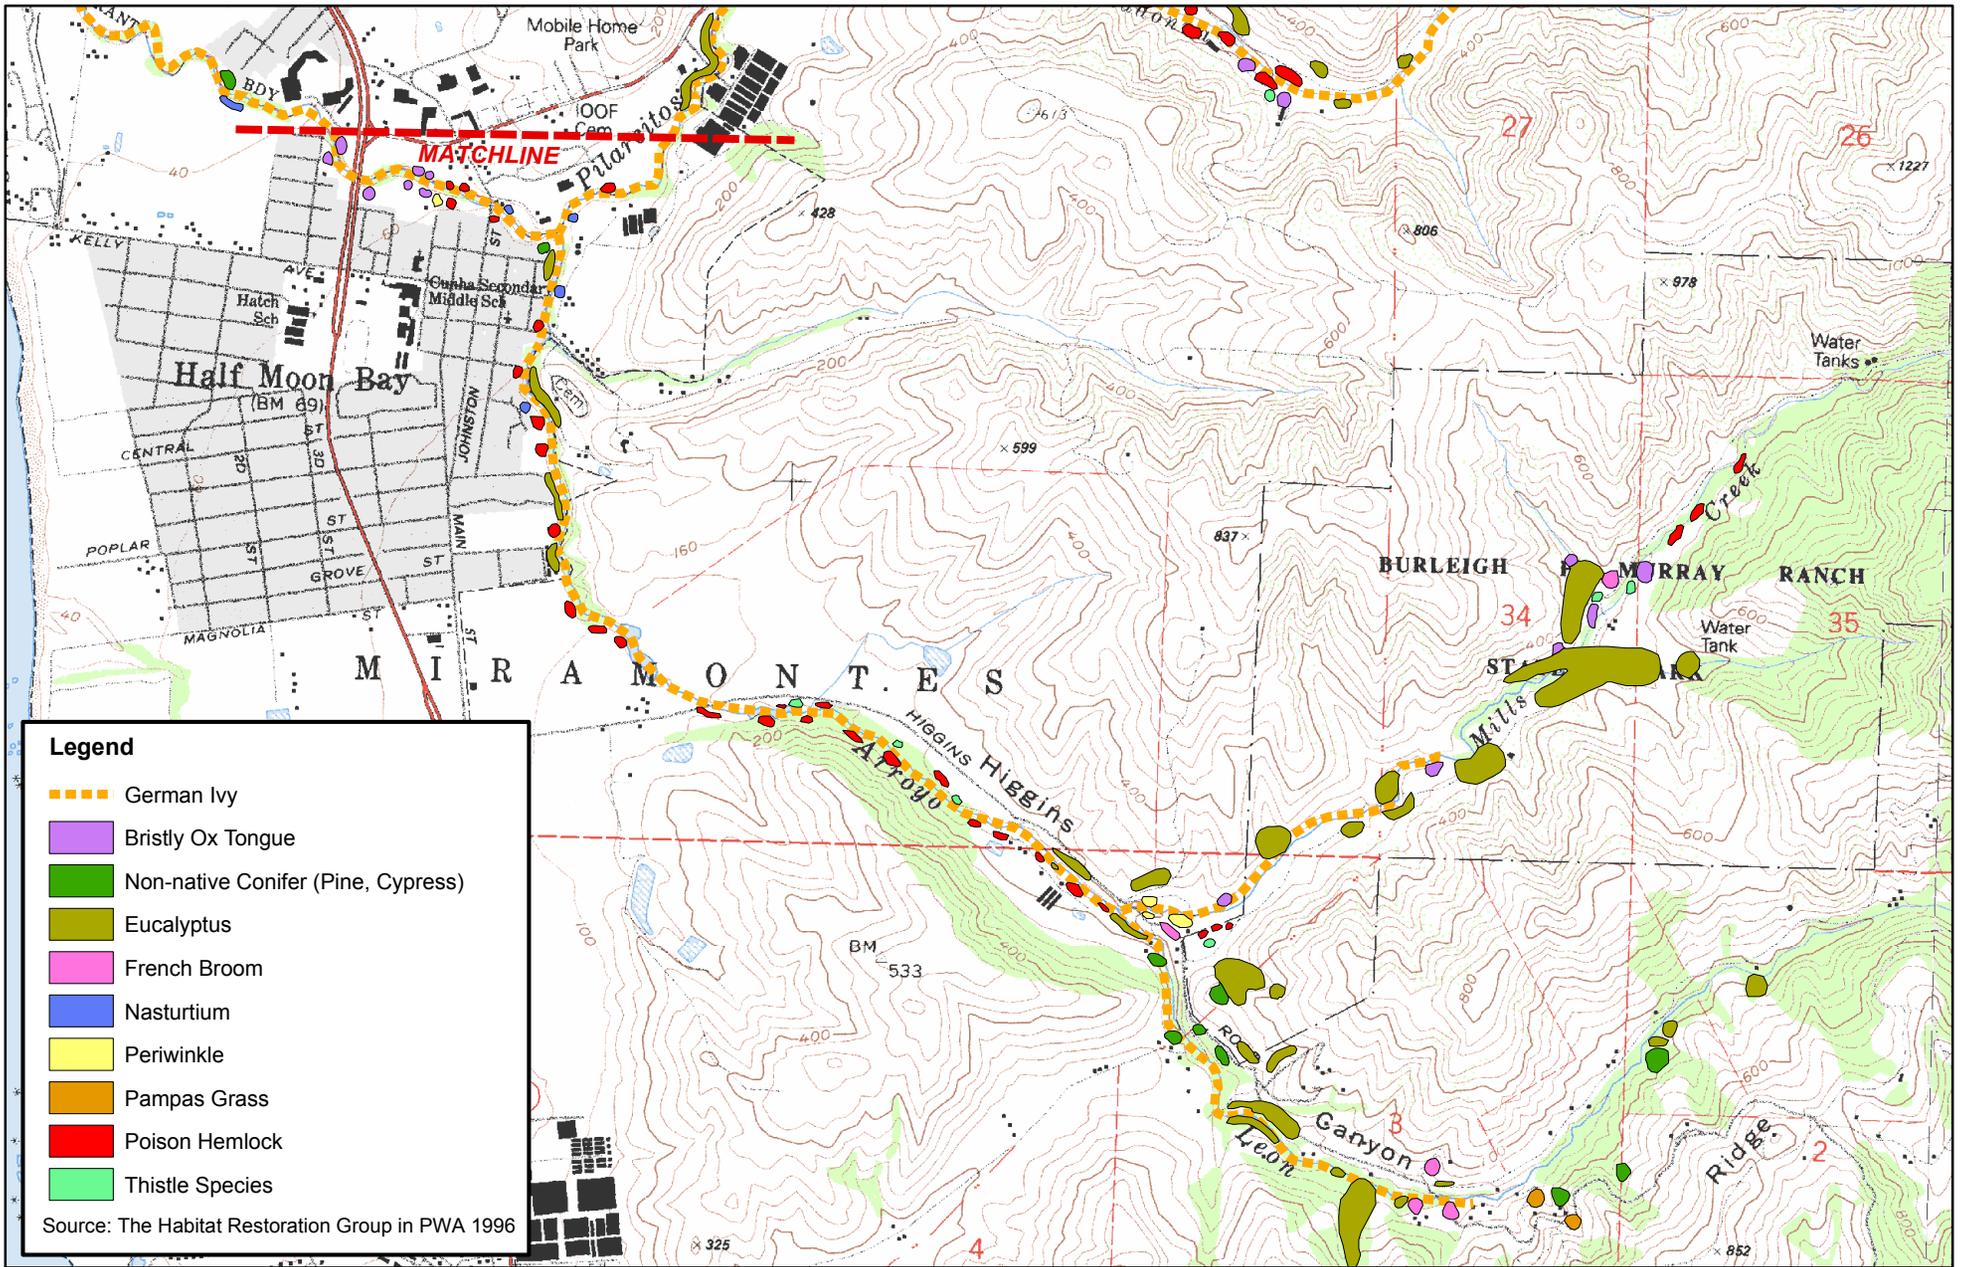
figure 35

- - - German Ivy
- Bristly Ox Tongue
- Non-native Conifer (Pine, Cypress)
- Eucalyptus
- French Broom
- Nasturtium
- Periwinkle
- Pampas Grass
- Poison Hemlock
- Thistle Species

Source: The Habitat Restoration Group in PWA 1996

Invasive non-native species are present in all seven tributaries of Lower Pilarcitos, frequently occurring with high percent cover (PWA 1996). Blue gum eucalyptus and Cape ivy appear to be the most pervasive and cover the greatest surface area (Figure 35 and Figure 36). Additional invasive species that occur in the watershed include: poison hemlock, bristly ox-tongue (*Picris echioides*), black mustard (*Hirschfeldia incana*), Italian thistle (*Carduus pycnocephalus*), milk thistle (*Silybum marianum*), periwinkle (*Vinca major*), garden nasturtium (*Tropaeolum majus*), pampas grass (*Cortaderia spp.*), French broom (*Genista monspessulana*), and small-leaf spiderwort (*Tradescantia fluminensis*) (Figure 35 and Figure 36). The most highly invaded areas appear to be along lower Nuff Creek near the confluence with Pilarcitos Creek, Mills Creek, and the lower reaches of Pilarcitos Creek. Detailed information about the amount and location of invasive species are not available for the upper watershed.

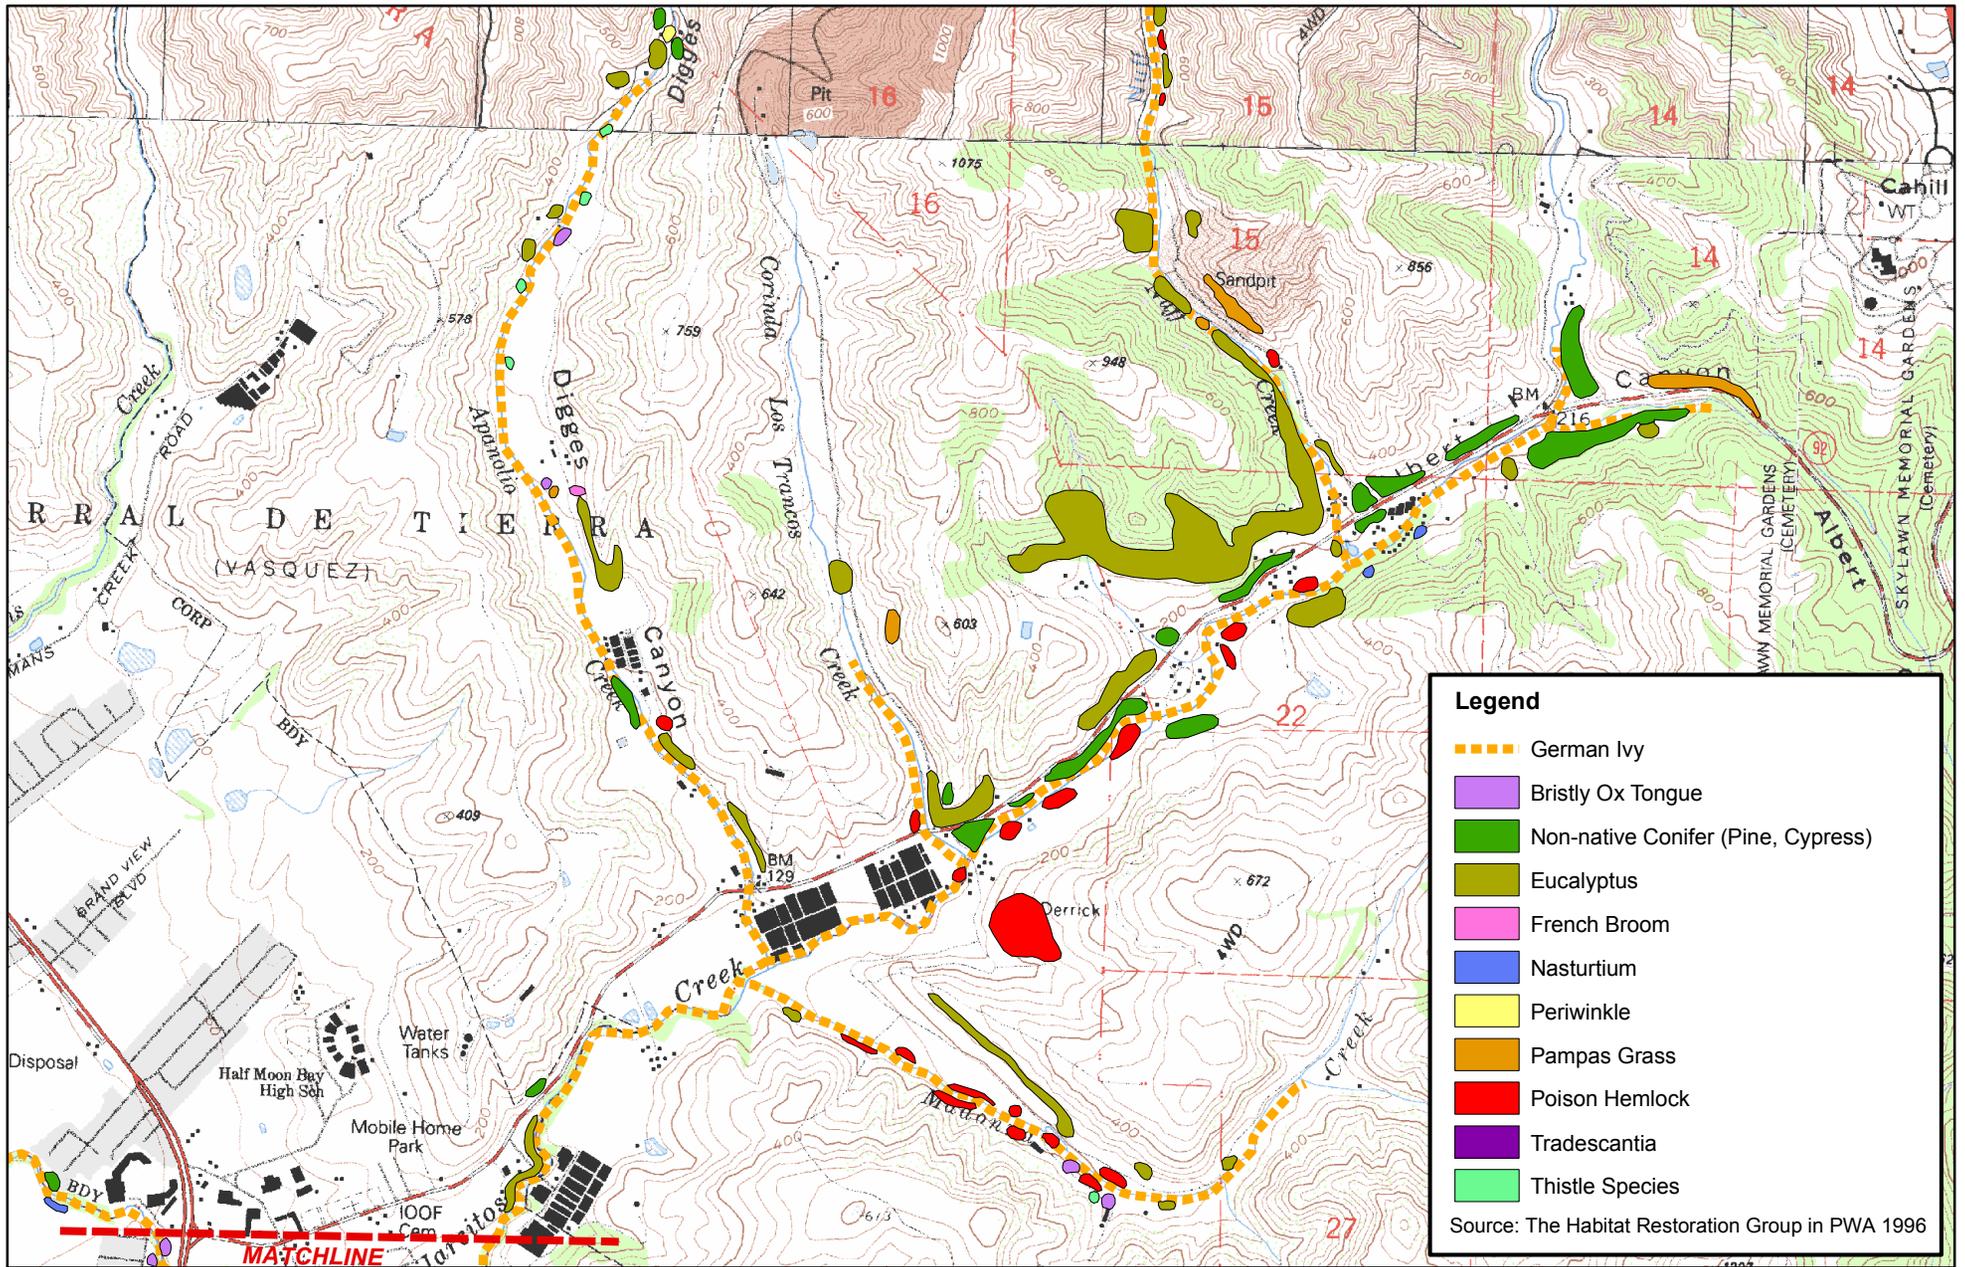
figure 36

- Figure 36. Locations of Significant Concentrations of Invasive, Non-native Plant Species (North)
- Figure 37. Vegetation Communities
- Figure 38. California Natural Diversity Database (CNDDDB) Plant Records
