Alves Water Tank

Coastside County Water District
Half Moon Bay, CA

Structural Review and Retrofit Strategy Report

May 29, 2018

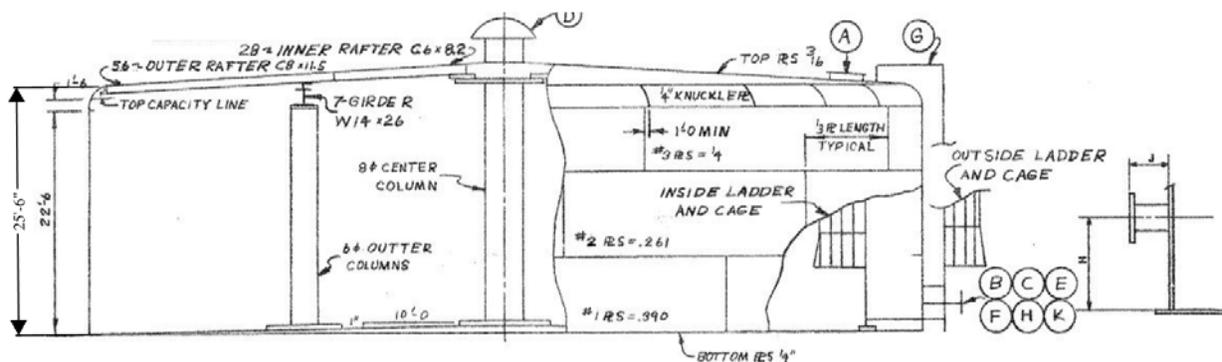
Figure 3: Alves Tank Section
(Source: Alves Tank Shop Drawing)

The Alves water tank is a flat bottom welded carbon-steel tank, and is 120 feet in diameter. The tank is supported on, but not anchored to, a reinforced concrete ringwall foundation. See Figure 3 below for tank section from the available shop drawings. The information provided below is based on available shop drawings and construction plans for the Alves Tank as well as observations made while visiting the site.
